Lahaina Fire Incident Analysis Report

Steve Kerber
Derek Alkonis

September 13, 2024
Columbia, MD

Fire Safety Research Institute

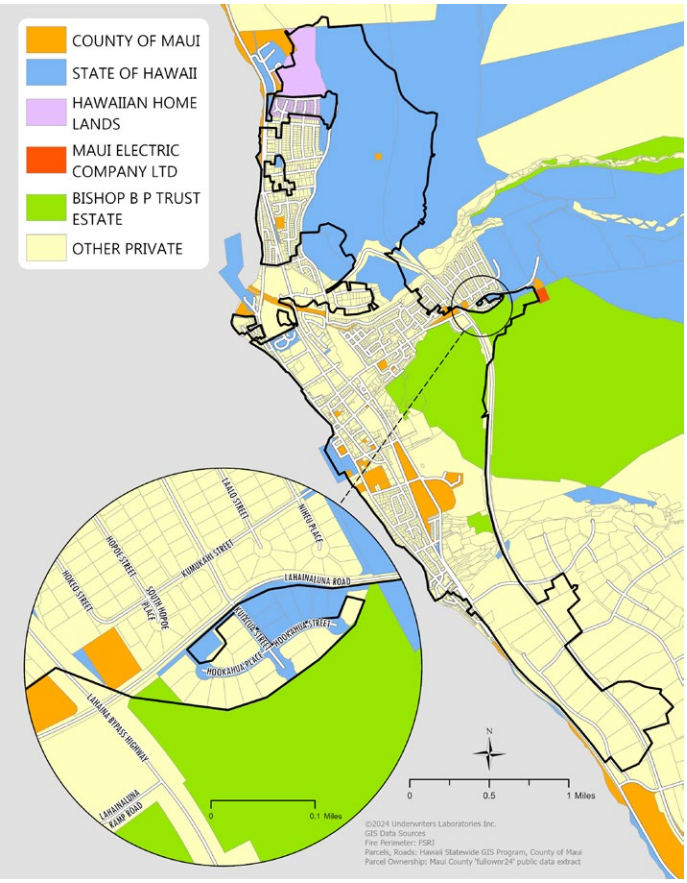
For example, two (2) of the four (4) August 2023 fires impacted state lands. In Lahaina, one (1) parcel of the impacted wildland area is under management of DLNR-Land Division, with no record of vegetation management. Several smaller parcels within the impacted developed area are owned and managed by the State Department of Education (within the blue State of Hawai‘i area), also with no clear accountability for wildfire risk reduction or vegetative fuels management (Figure 3.3.2.2).

Figure 3.3.2.2 Map of Lahaina showing burn perimeter and land ownership. Detail shows Lahaina fire origin just northeast of Hoʻokahua Street where the County of Maui, State of Hawaiʻi, and private lands converge. Source: Hawaiʻi Statewide GIS Program, Office of Planning and Sustainable Development, State of Hawaiʻi.[85]

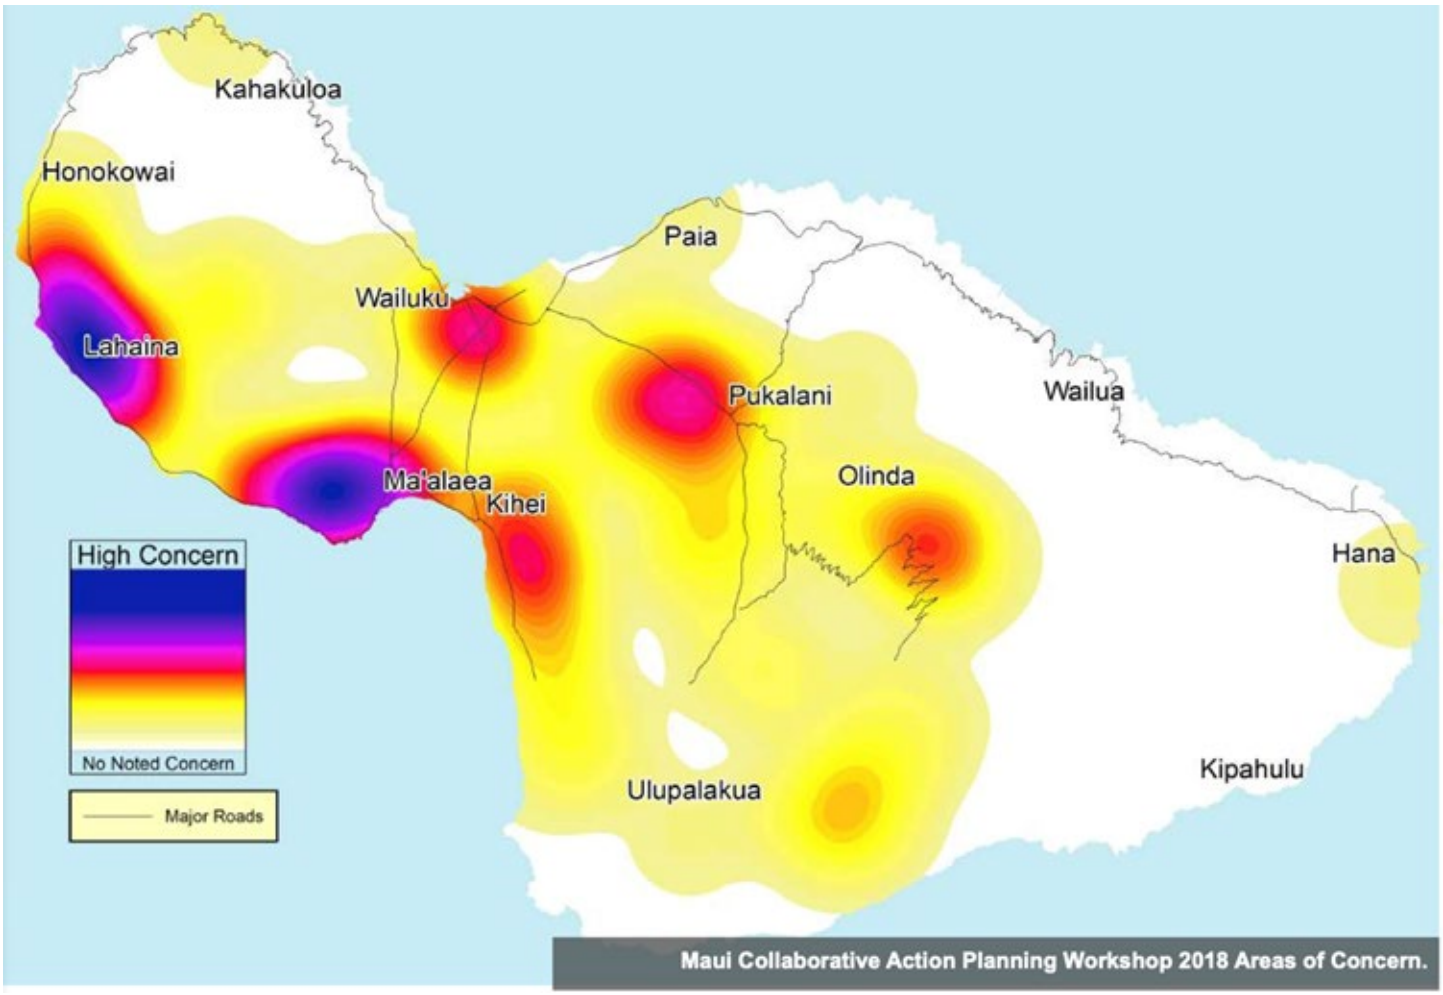
Despite Lahaina being identified as one of the highest priority areas for vegetative fuels management (Figure 3.3.8.1), it appears that relatively little work was actually done, due to the continued combination of funding challenges and lack of incentives, penalties, or financial support for private landowners to participate.[107]

Figure 3.3.8.1 Fire Risk Heat Map: In 2018, 41 individuals from Maui representing government organizations, businesses, private landowners, and residents participated in a workshop to identify and prioritize county areas by their values at risk, hazardous vegetation, and where to start the hazard mitigation effort. The areas of highest concern represent where the participants selected as high priority for each of the three (3) categories.[108]

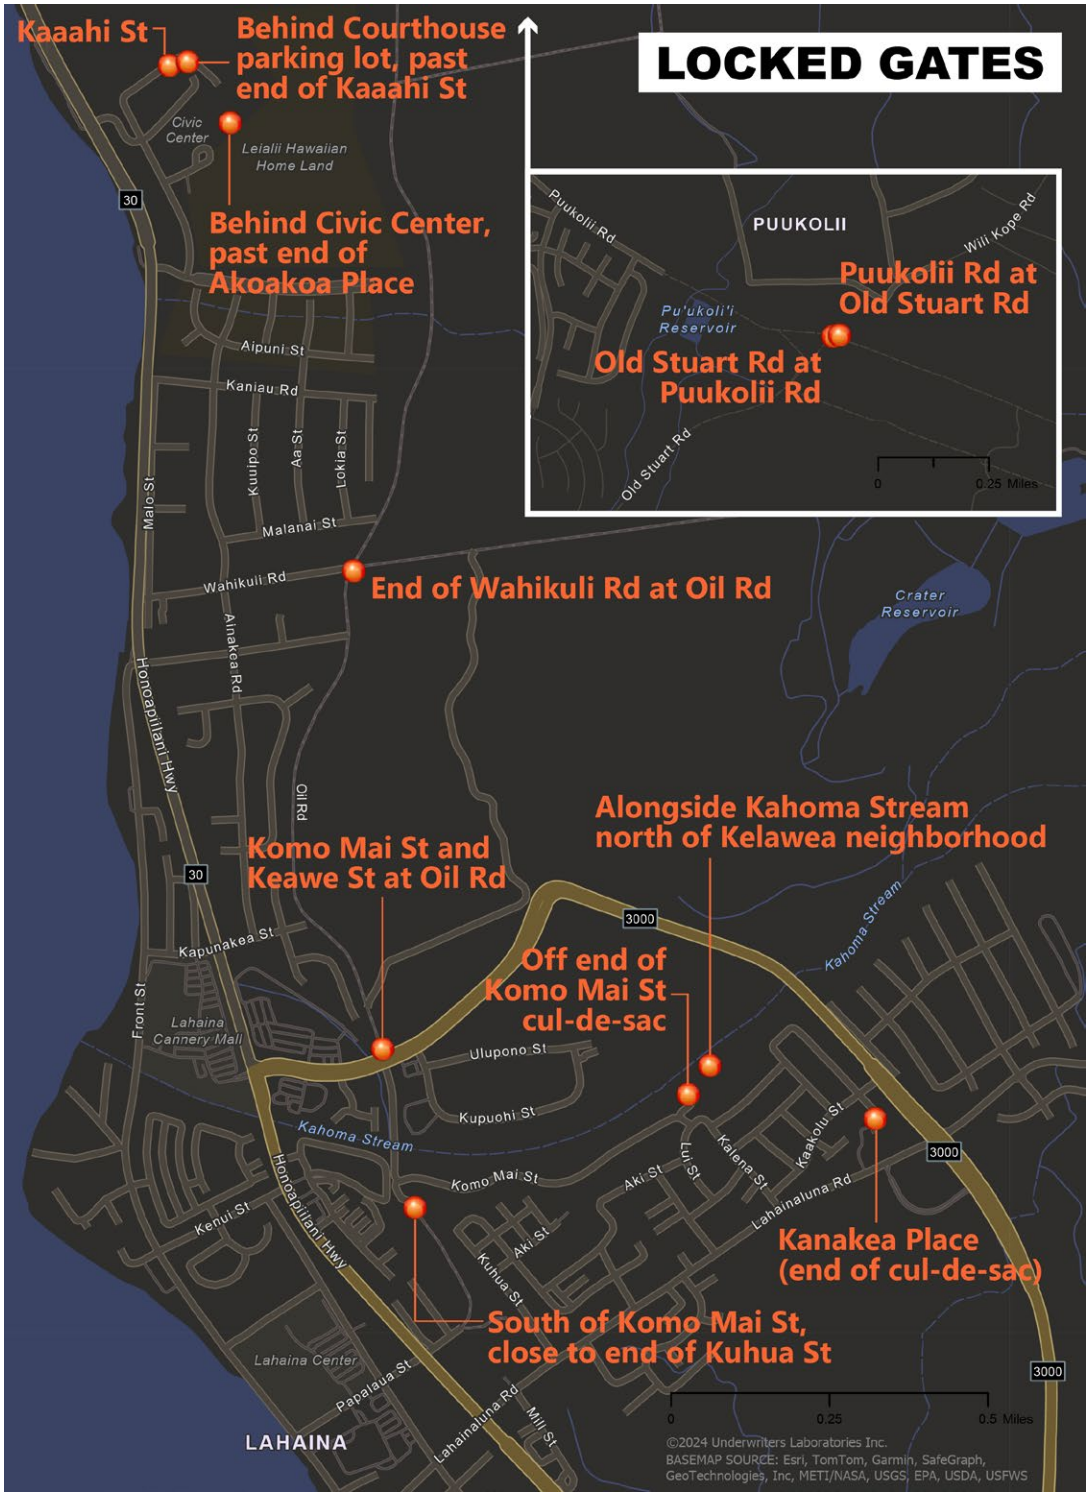
Figure 3.4.2.4.3 Locked Gates Map. Map showing location of locked games preventing access to dirt roads used during August 8-9, 2023. MPD officers shared how they had to cut the locks to open the gates to allow vehicles to escape the fire and smoke.

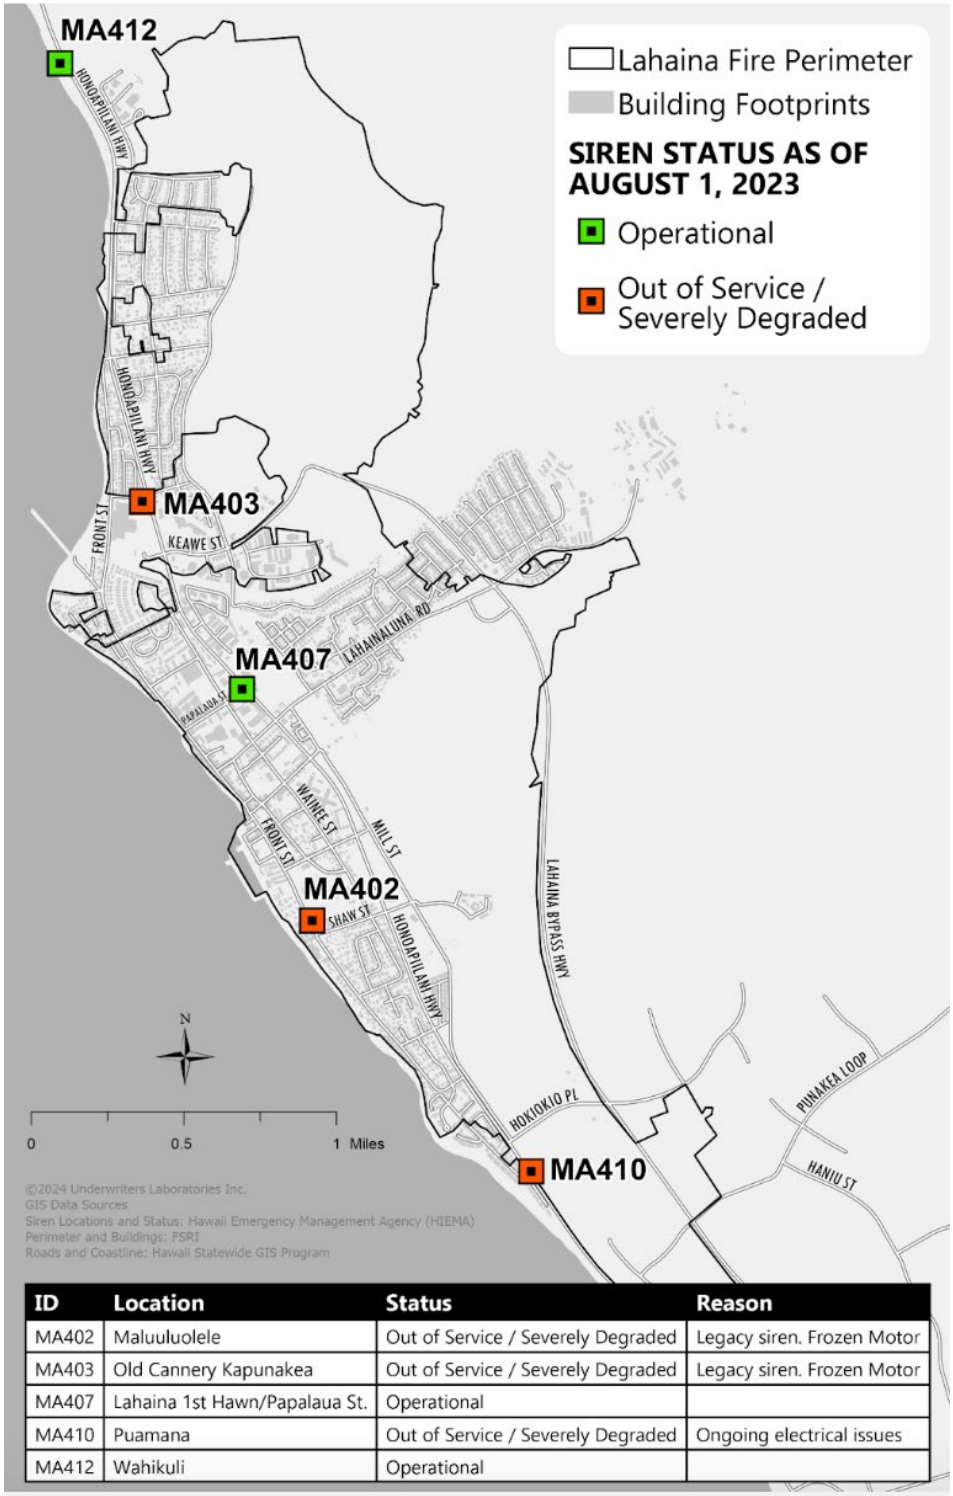
On August 8, 2023, there were five (5) sirens located off of Hwy-30 and near the coastline in the area of the Lahaina PM fire[152] (Figure 3.5.1.2.1). According to siren test records (Appendix Section 6.11) provided by both MEMA and HI-EMA, siren MA407, located near Papalaua Street and Hwy-30, and siren MA412, located off Hwy-30 just north of the Lahaina Civic Center, were the only two sirens operable at the time of the fire.

The records provided are exception-type reports, where only inoperable sirens are listed for each county. Although siren's MA407 and MA412 may have been operable on or before August 8, 2023, they were also very likely inoperable throughout August 8, 2023, due to the area experiencing intermittent cell service. Without a reliable cell signal, it would have been difficult to activate them.

ID	Location	Status	Reason
MA402	Maluuluolele	Out of Service / Severely Degraded	Legacy siren. Frozen Motor
MA403	Old Cannery Kapunakea	Out of Service / Severely Degraded	Legacy siren. Frozen Motor
MA407	Lahaina 1st Hawn/Papalaua St.	Operational	
MA410	Puamana	Out of Service / Severely Degraded	Ongoing electrical issues
MA412	Wahikuli	Operational

Figure 3.5.1.2.1 Map displaying locations and functional status of Lahaina outdoor warning sirens as of August 1, 2023 (first business day of the month = siren monthly test day). Base map provided by https://hiema.maps.arcgis.com/apps/dashboards/226e62cd78f340c29e52d4f38c46ac21. Siren status and maintenance records provided by MEMA and HI-EMA.

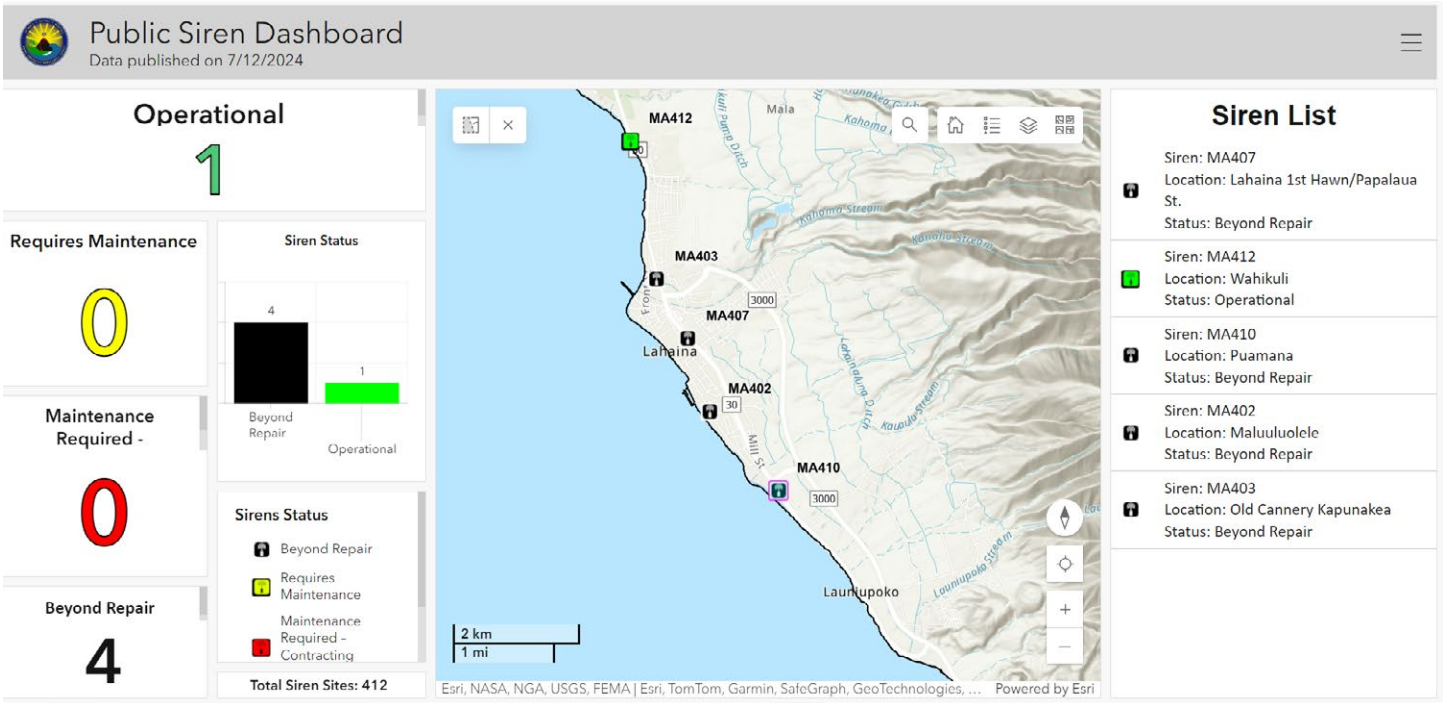
Figure 3.5.1.2.2 The public sirens in Lahaina on August 8, 2023, and their operational status as of July 12, 2024. Source: ARCIS.

The status of the State of Hawai'i Outdoor Warning Siren System is shared via the Public Siren Dashboard.[153] The July 12, 2024, dashboard for the Lahaina area in Figure 3.5.1.2.2 indicates that MA412, just north of the Lahaina Civic Center, is currently (as of July 2024) the only operable siren.

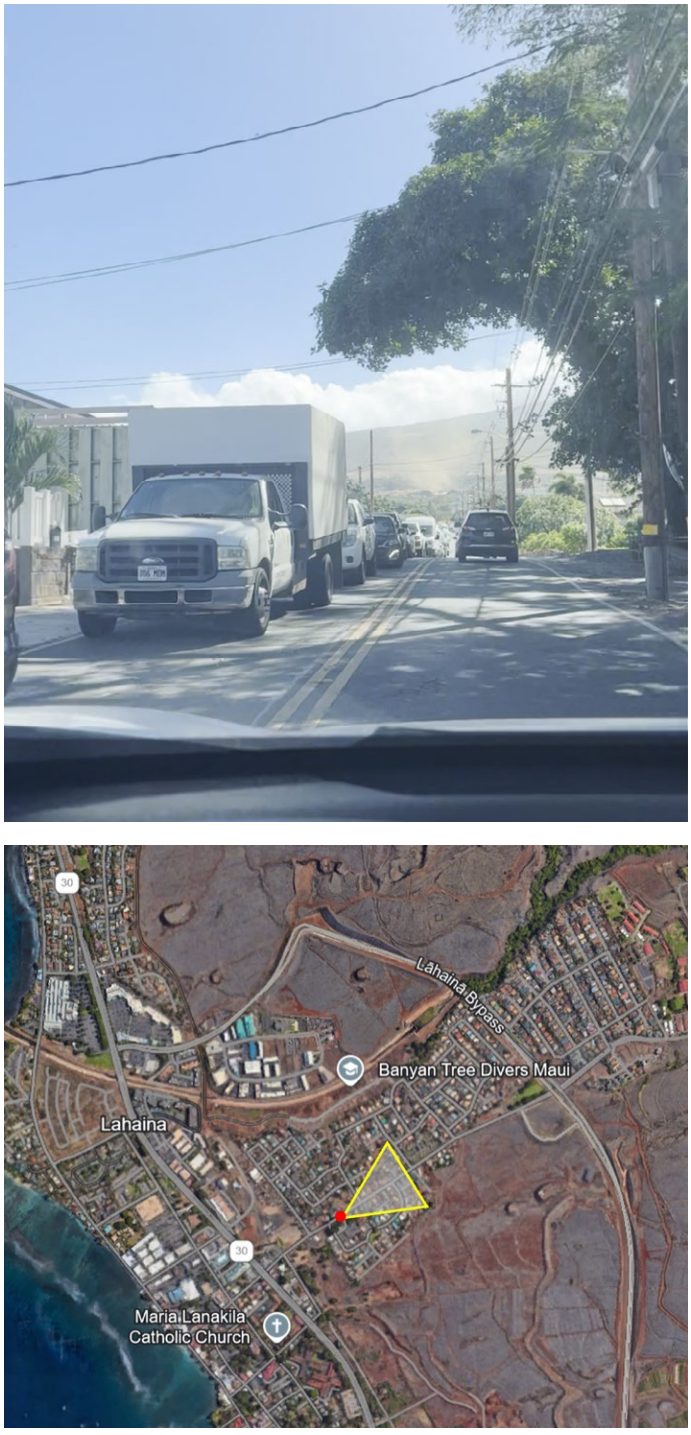
Figure 3.7.7.3.1 Video image captured on August 8, 2023, at 09:07, taken from a vehicle traveling eastbound (mauka) on Lahainaluna Road. At the far east end (mauka), a dust cloud can be seen near the location where the Lahaina AM fire burned. Insert: Viewpoint looking east (mauka) on Lahainaluna Road.

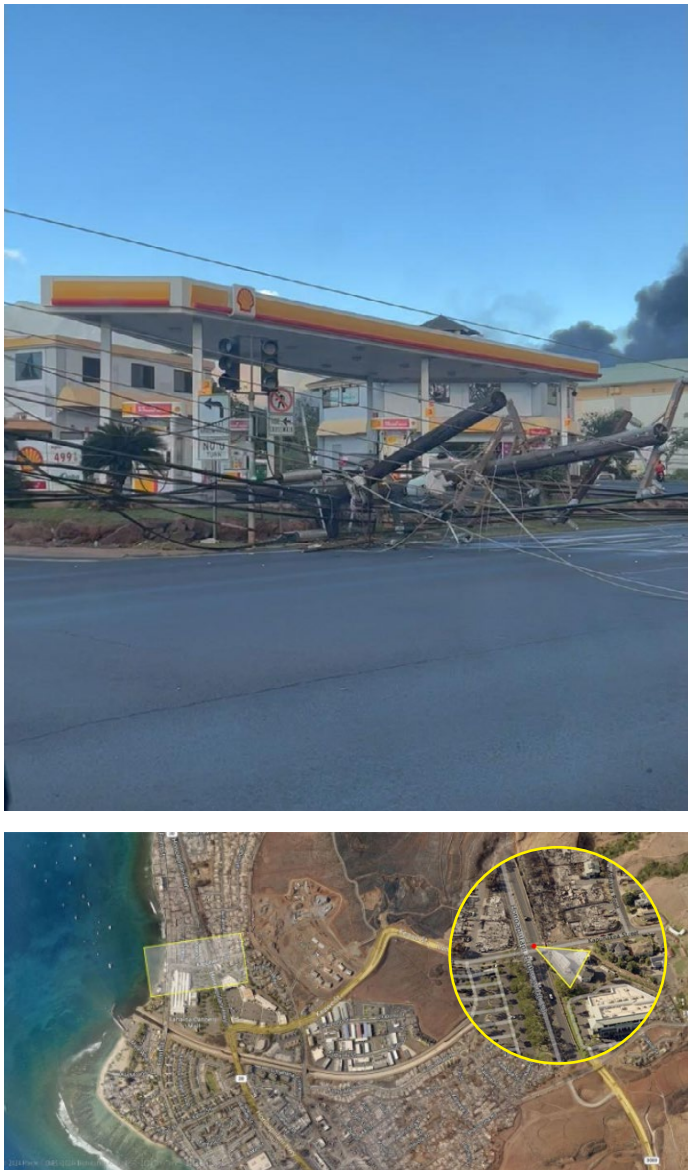
Figure 3.8.2.1 Several downed utility poles and powerlines in the northbound lane of Hwy-30 and Kapunakea Street. Photo taken August 8, 2023, at 16:52. Inset: Viewpoint of photo of downed utility poles and electrical lines at Hwy-30 and Kapunakea Street.

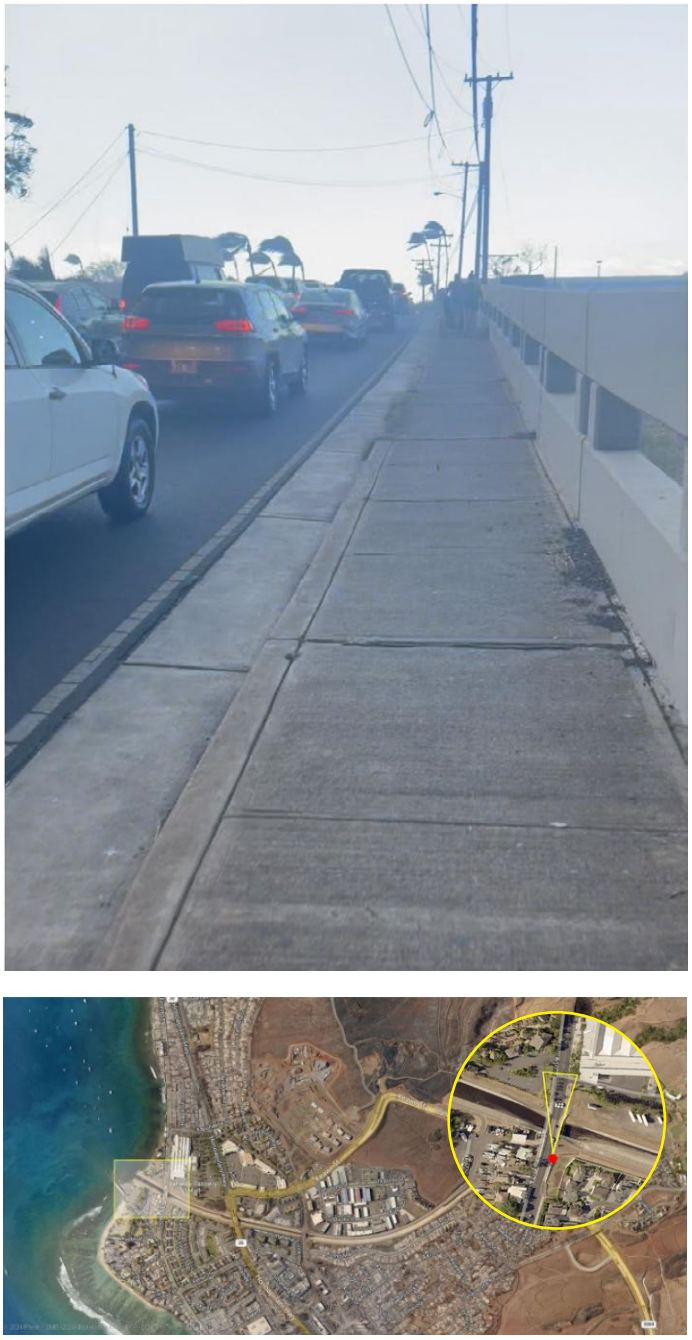
Even without these additional challenges blocking traffic flow, the Lahaina area had inherently limited access and egress routes, which became even more problematic during evacuations. The restricted road network was unable to handle the sudden surge in traffic as residents and tourists tried to navigate and evacuate the Lahaina area simultaneously.

These limited egress points meant any blockage, disabled vehicle, or accident could hinder residents' ability to evacuate quickly.

Figure 3.8.2.2 Northbound Front Street traffic over Kahoma Stream on August 8, 2023, at 17:05. Inset: Viewpoint of northbound Front Street traffic over Kahoma Stream on August 8, 2023, at 17:05.

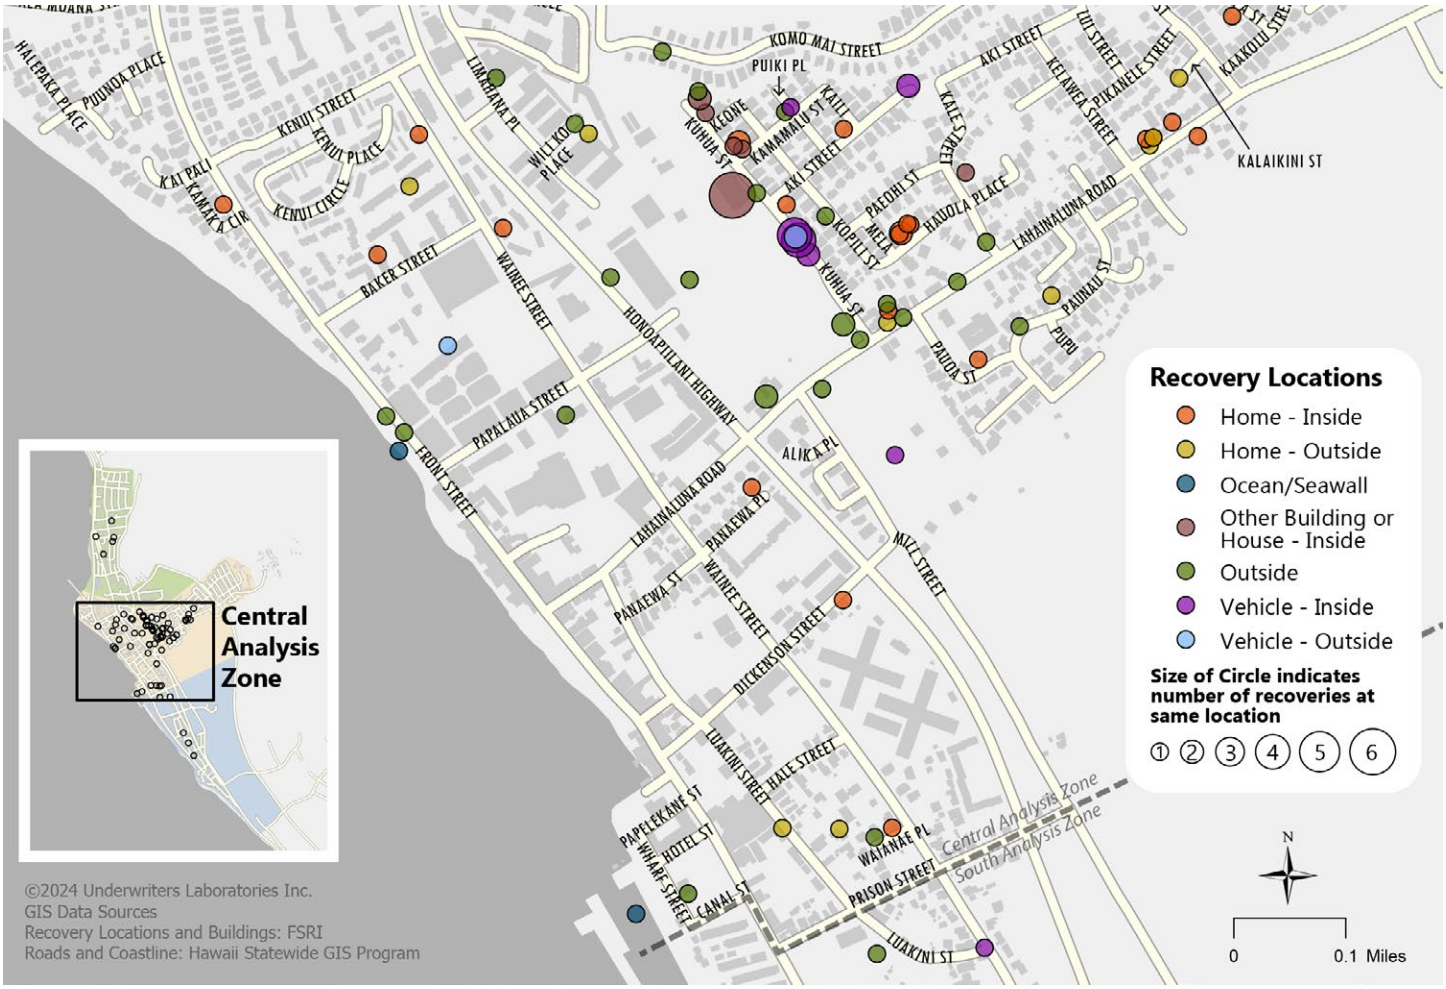
Figure 3.8.10.1 Recovery locations and descriptions of fire fatalities for the central analysis zone.

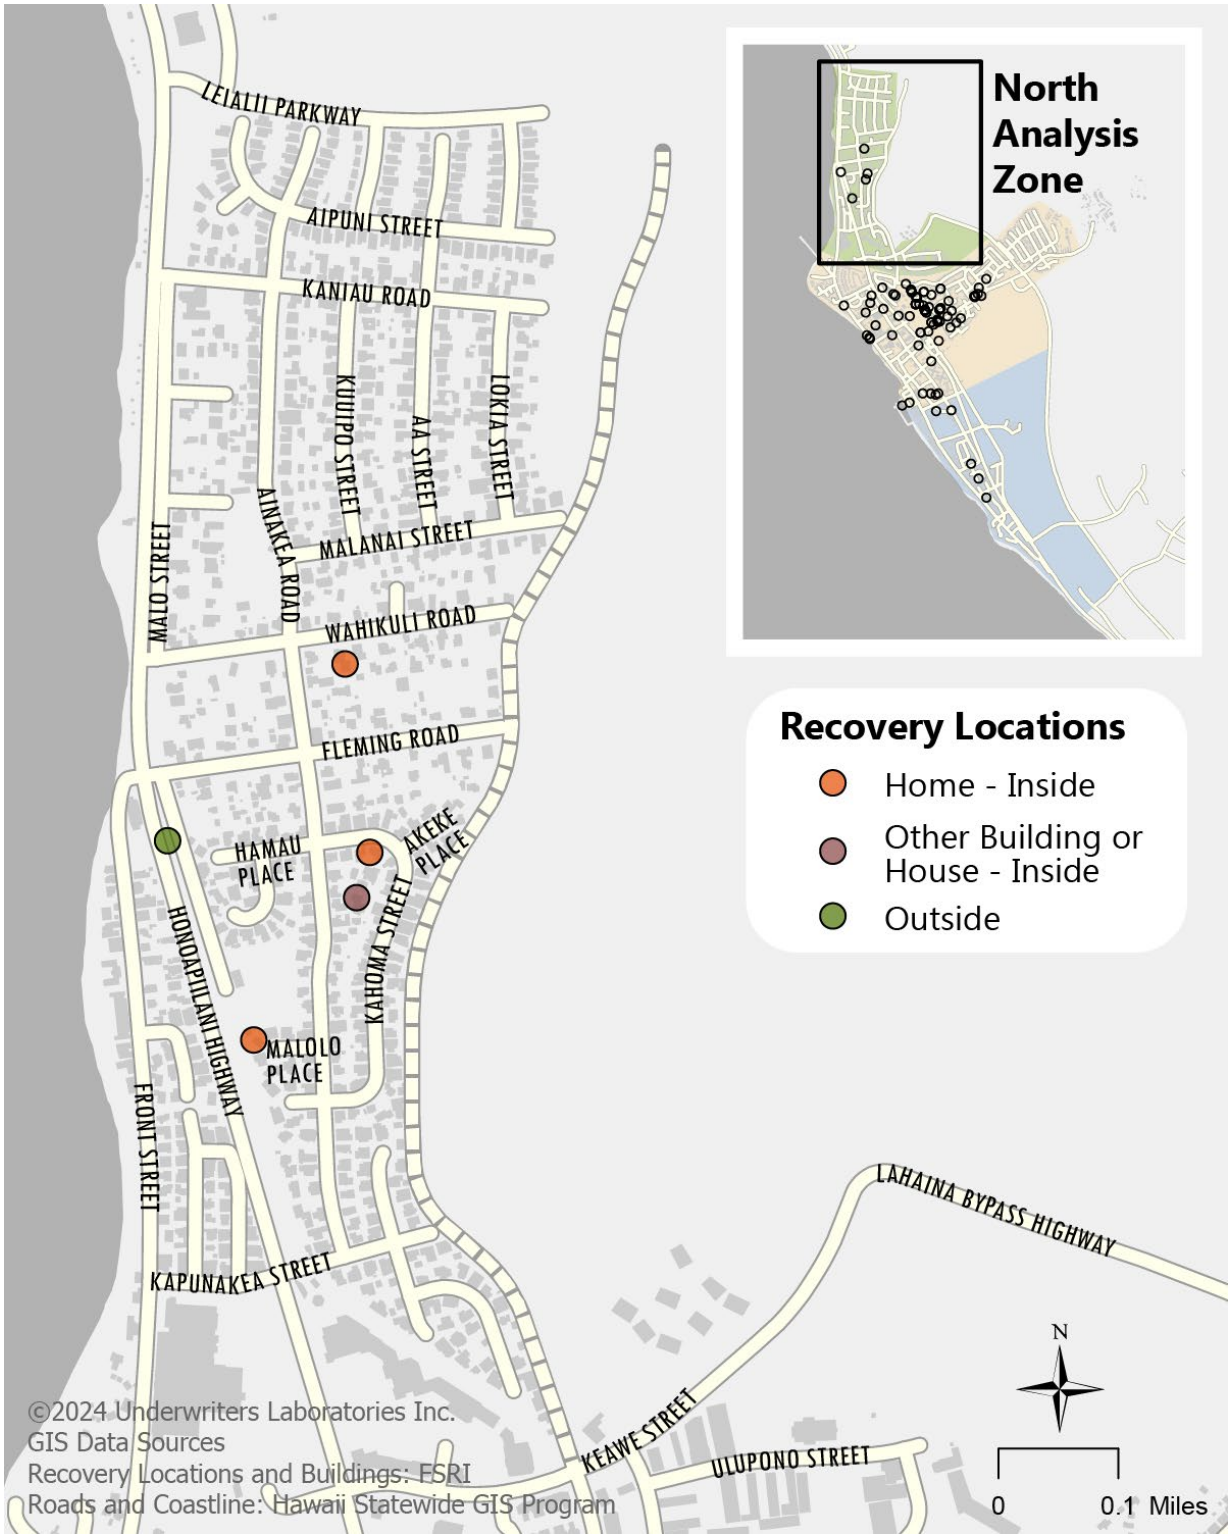
Figure 3.8.10.2 Recovery locations and descriptions of fire fatalities in the north.

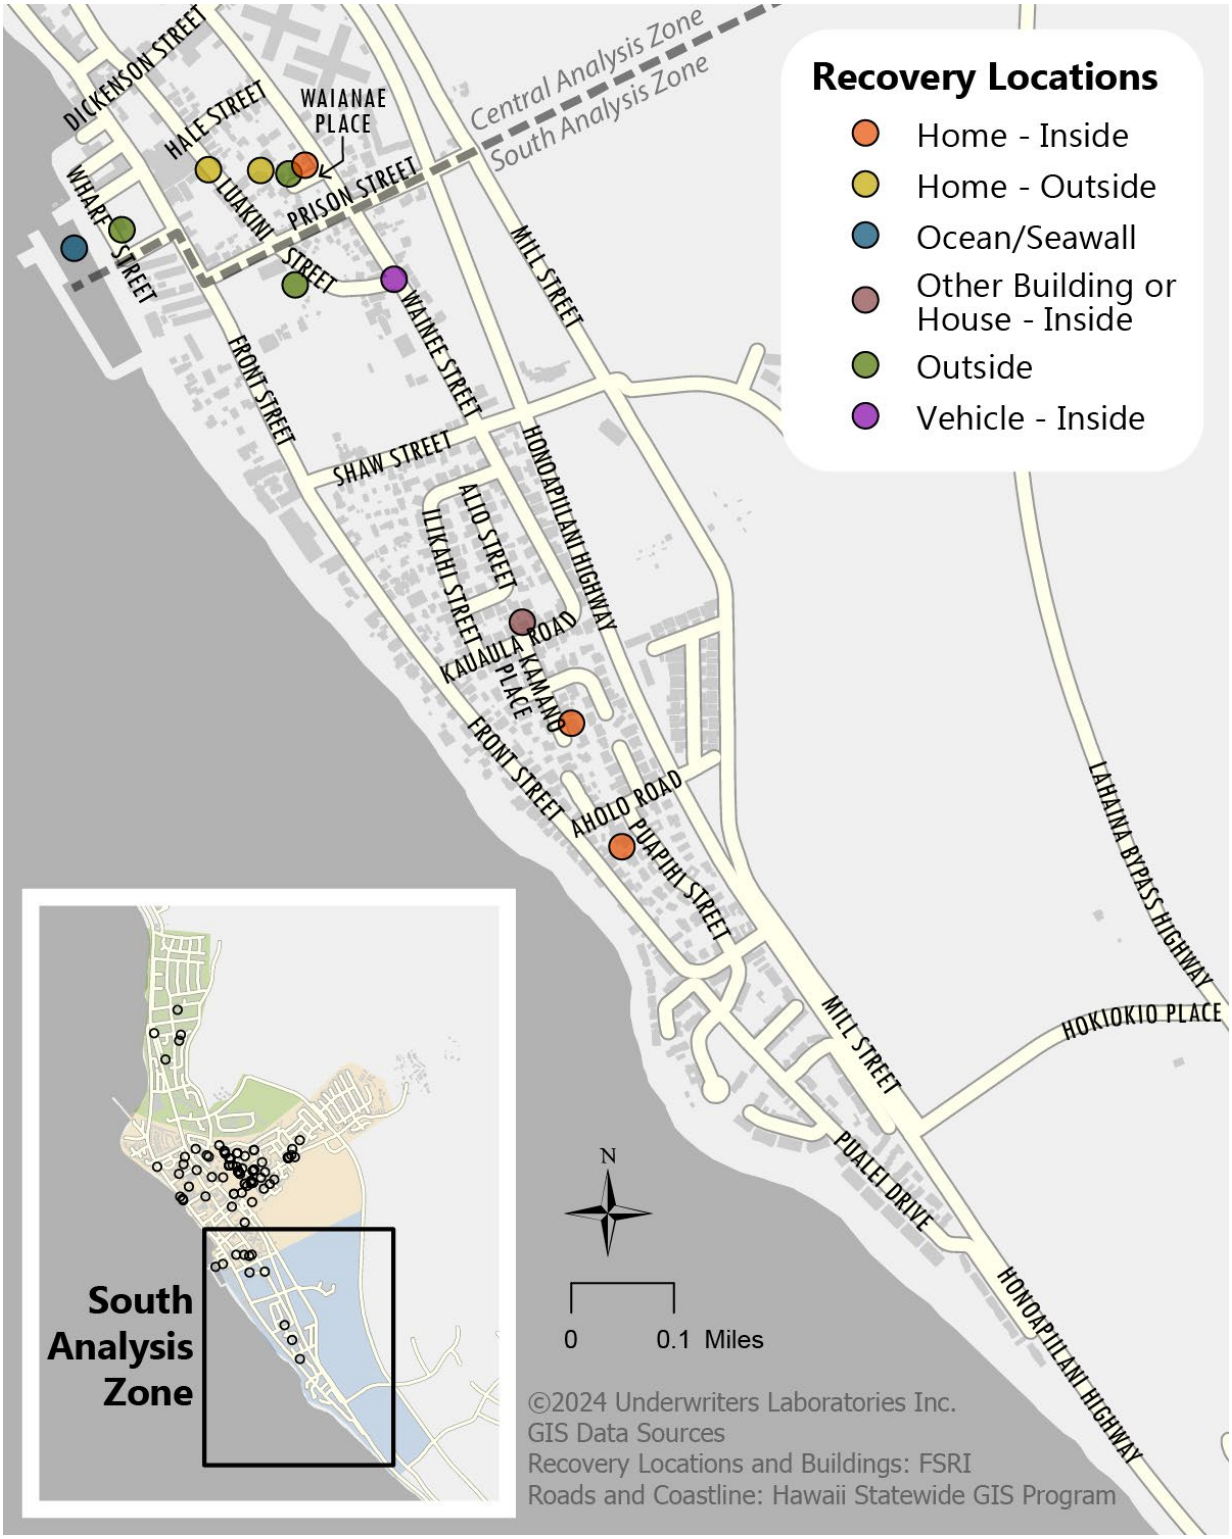
Figure 3.8.10.3 Recovery locations and descriptions of fire fatalities in the south.

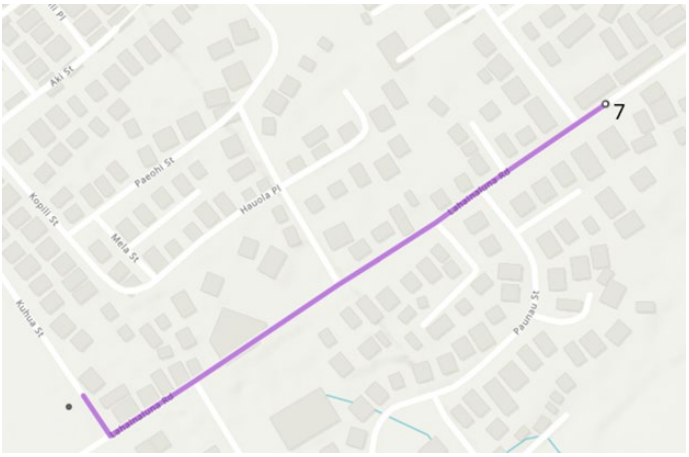
There were three (3) clusters of fatalities located in the Lahainaluna neighborhood. The first was at the Hale Mahaolu Eono independent-living apartment complex at 8[redacted] Kelawea Street. Seven (7) residents were among the fatalities. Six (6) were recovered on the facility property and one (1) evacuated to the area of Lahainaluna Road and Kuhua Street and was recovered there (Figure 3.8.10.4).

Figure 3.8.10.4 Evacuation path of the resident of the Hale Mahaolu Eono independent-living apartment complex at 8[redacted] Kelawea Street who was recovered on Kuhua Street.

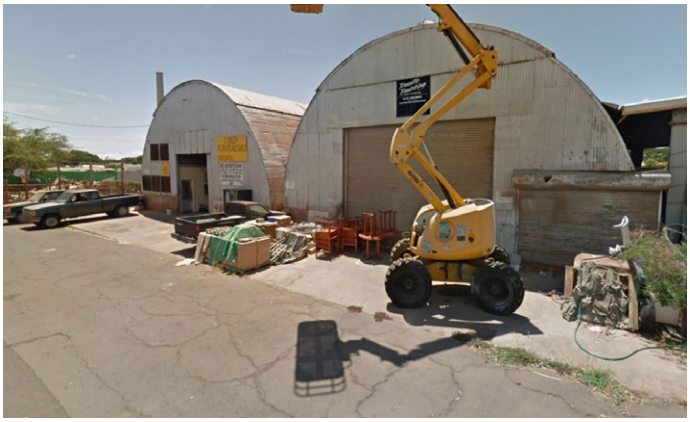
The second cluster of fatalities was located inside 8[redacted] Kuhua Street. Six (6) people sought refuge inside a structure described in MPD documents as a “quonset hut.” This lightweight prefabricated structure of corrugated, galvanized steel with a semi-circular cross-section faced Kuhua Street. The remainder of Kuhua Street was lined with a security fence that residents described as well-reinforced due to previous vandalizations of the mill property that ran along most of the western side (makai) of Kuhua Street (Figure 3.8.10.5).

Figure 3.8.10.5 Front of 8[redacted] Kuhua Road from Google Street View (Sept 2011).

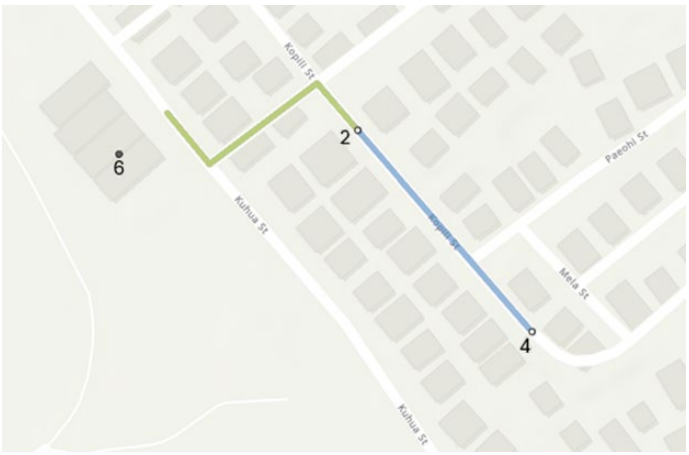
Based on resident reports and media stories, a large tree came down blocking Kuhua Street just south of Aki Street, and a utility pole came down across Kuhua Street just north of Aki Street. All six (6) victims lived on Kopili Street and likely traveled north on Kopili Street, then west on Aki Street to Kuhua Street, where they became trapped, unable to go north or south without hitting an obstruction (Figure 3.8.10.6).

Figure 3.8.10.6 Potential egress routes for fatalities recovered from 8[redacted] Kuhua Street.

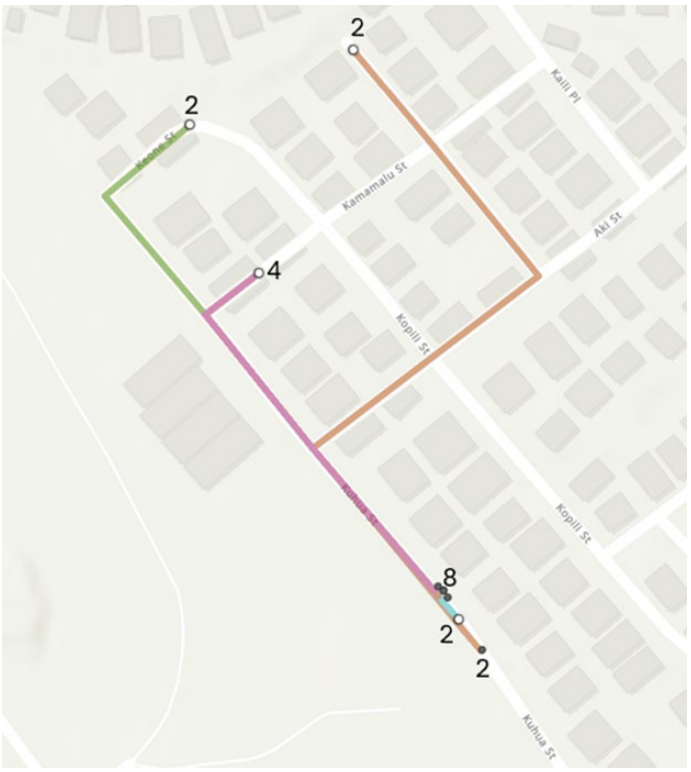
This address is where two (2) of the victims (Terri Thomas and Dale Richter) were reported to have lived. Tony Takafua, Salote Tone, Fa'aoso Tone, and Malui'fonua Tone were presumably evacuating from 9[redacted] Kuhua Street in their car headed south on Kuhua Street toward Lahainaluna Road. Juan Deleon and Ediomede Castillo were presumably evacuating from their home at 3[redacted] Keone Street in their car, headed south on Kuhua Street toward Lahainaluna Road (Figure 3.8.10.8).

It is not known what time they all reached this area. However, they were able to get past the area on the corner of Aki Street and Kuhua Street. The fire first reached the area of Kuhua Street and Lahainaluna Road at 15:57. At 16:25, homes were reported to be on fire in this area. The vehicles in front of 8[redacted] Kuhua Street were consumed by fire, while the vehicle in front of 8[redacted] does not appear to have been consumed by the fire (Figure 3.8.10.9).

Figure 3.8.10.8 Potential egress routes for those recovered in vehicles in front of 8[redacted]-8[redacted] Kuhua Street.

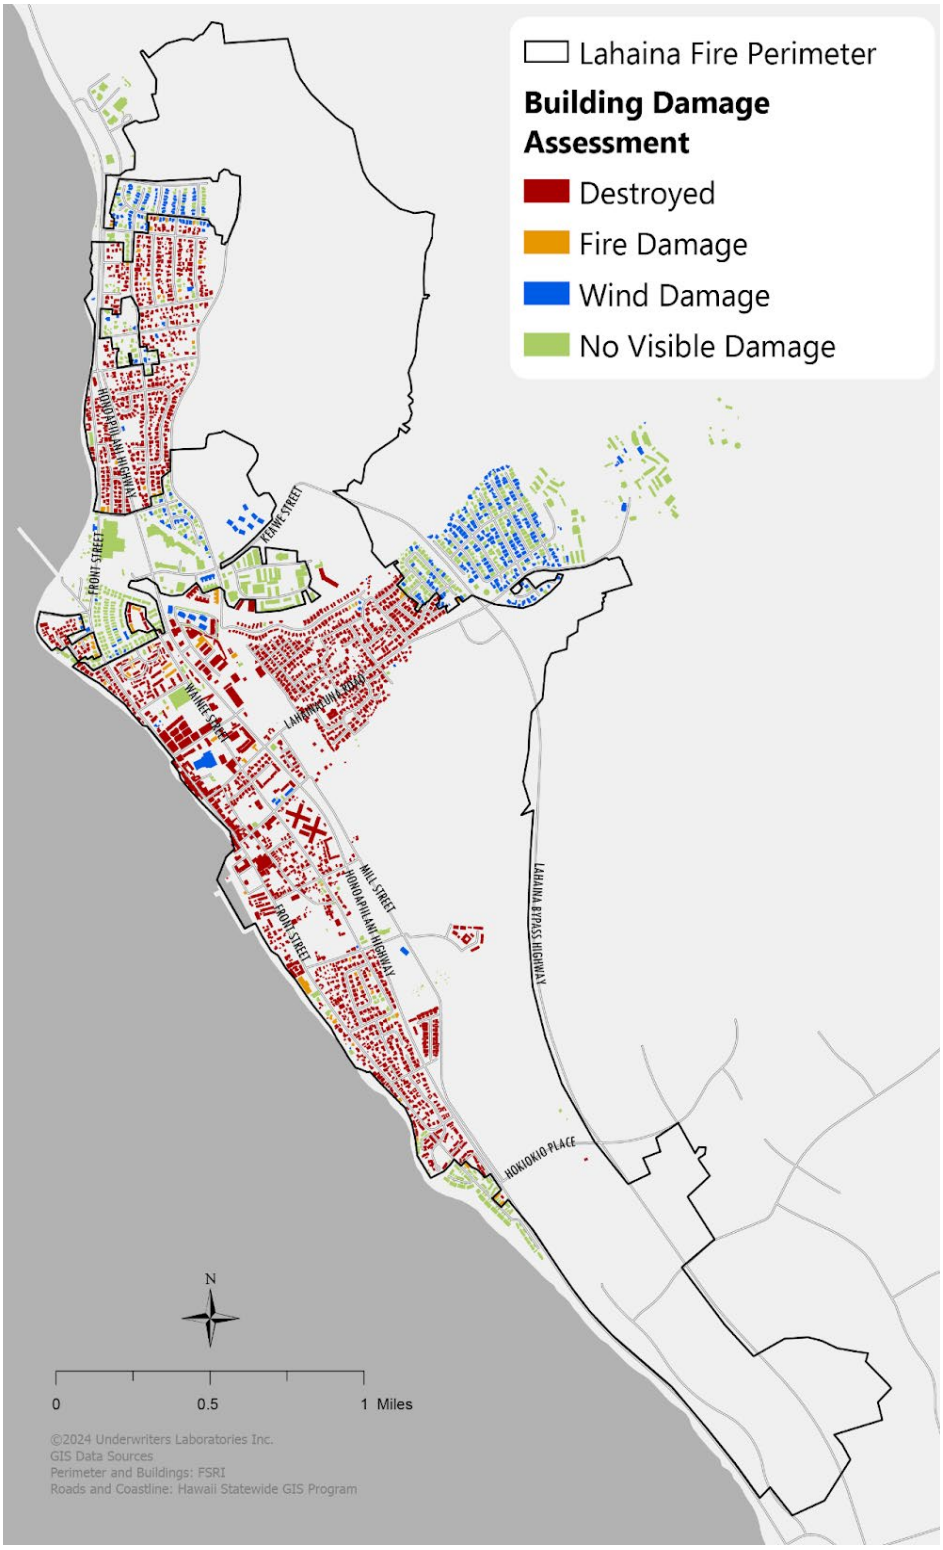
Figure 4.2.1.1 is the structure damage assessment based on data available and current understanding that combines information gleaned from previously published datasets with ground truth from Phase One evidence.

Figure 4.2.1.1 Structure damage assessment map of Lahaina as a result of the August 8-9, 2023 fire.

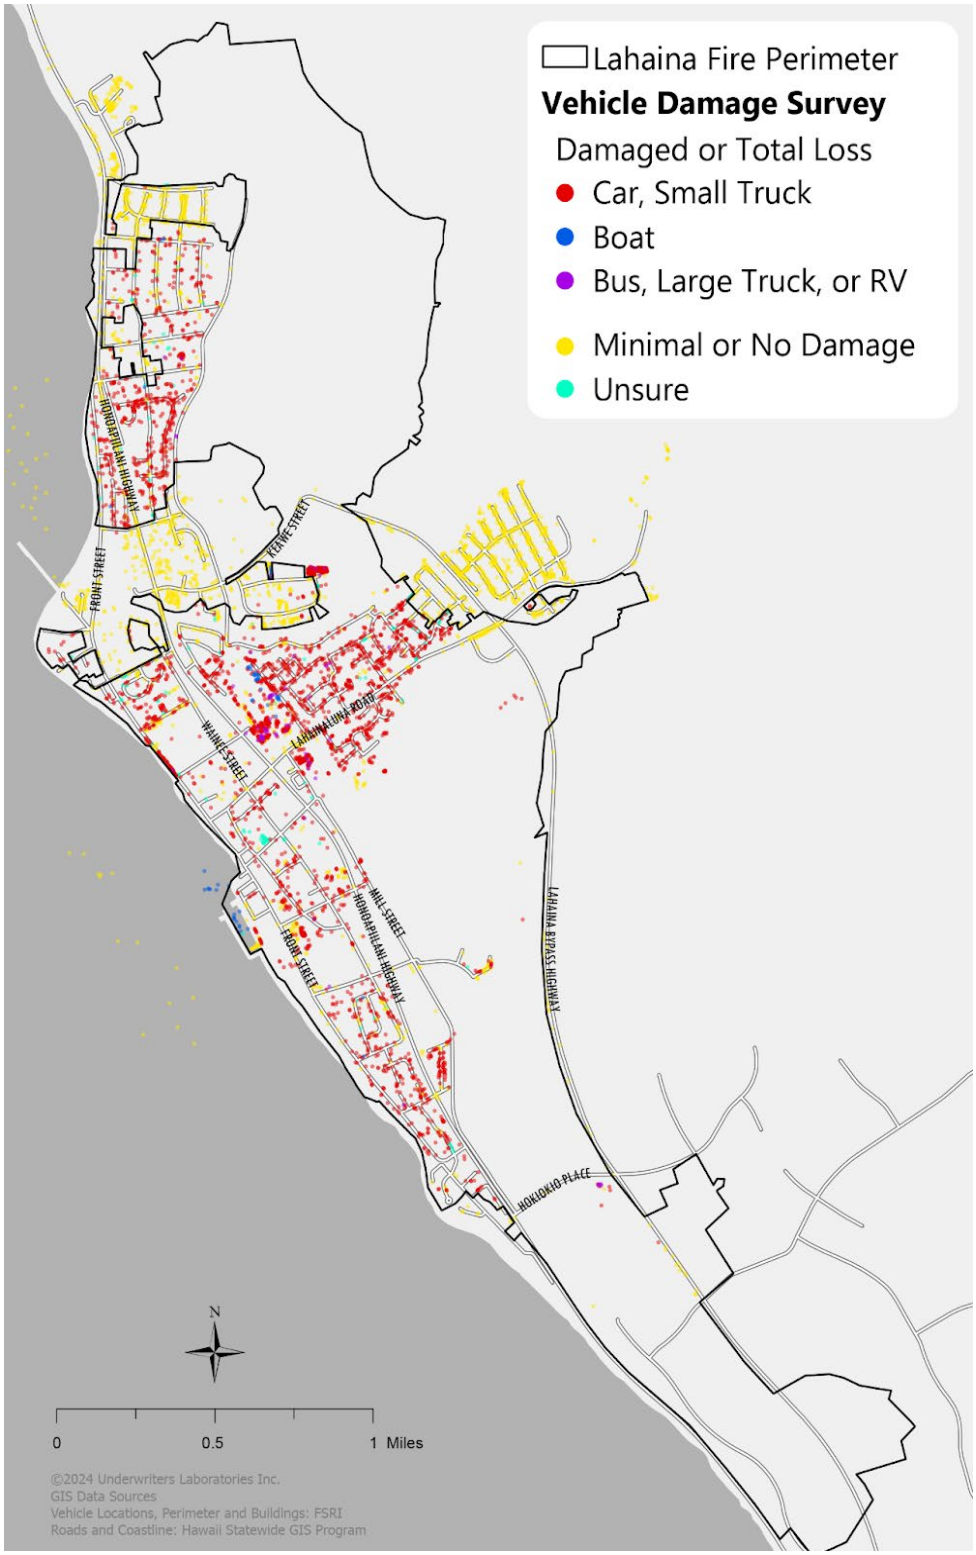
FSRI conducted a visual survey using post-fire aerial imagery captured August 11-13, 2023, to create a dataset of vehicle locations and damage classification (Figure 4.2.2.1). It is evident from the imagery (and as reported) that vehicles, both destroyed and undestroyed, were moved at some point during or after the incident.

Roads and streets were discussed previously in the Infrastructure and Evacuations sections. In the context of fire progression, roads may be considered a fuel break. Asphalt, concrete, gravel, and dirt roads can serve as fuel breaks to help stop the spread of wildfire. However in Lahaina, the number of vehicles and narrow road widths did not create sufficient discontinuity in fuel to hinder the wind-driven fire spread.

Figure 4.2.2.1 Overview of incident area with location of vehicles identified in aerial imagery captured August 11-13, 2023.

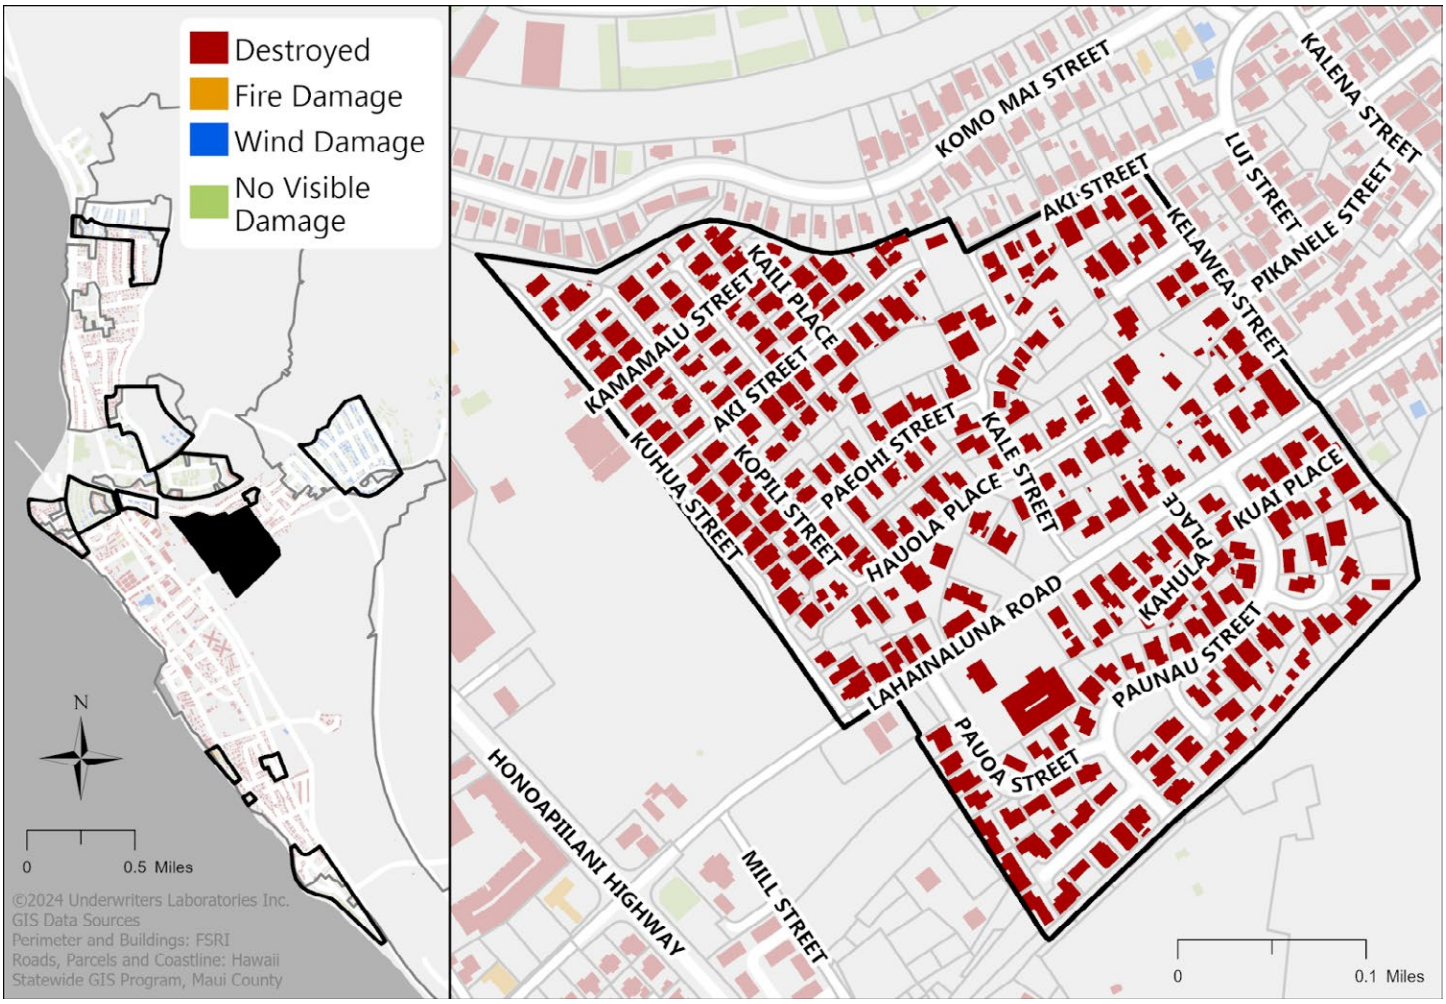
Figure 4.3.3.1.2 Damage classification assessment map of Kelawea Community analysis area.

The neighborhood is bound on the west (makai) by a large industrial area that had once been the Pioneer Sugar Mill, and was originally constructed as employee housing for the mill. All of the structures in this area were destroyed (Figure 4.3.3.1.2).

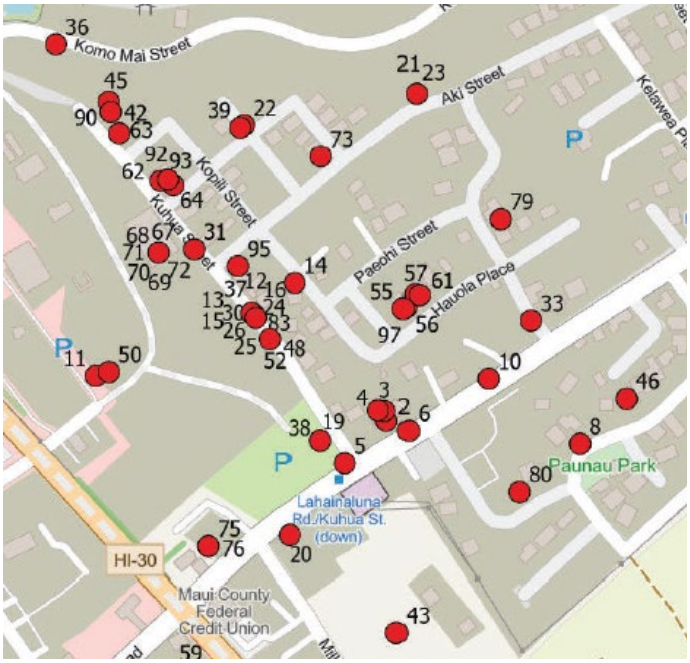
Figure 4.3.3.1.8 Fatality locations in this area as provided by the MPD.
