Lahaina Fire Incident Analysis Report

Steve Kerber
Derek Alkonis

September 13, 2024
Columbia, MD

Fire Safety Research Institute

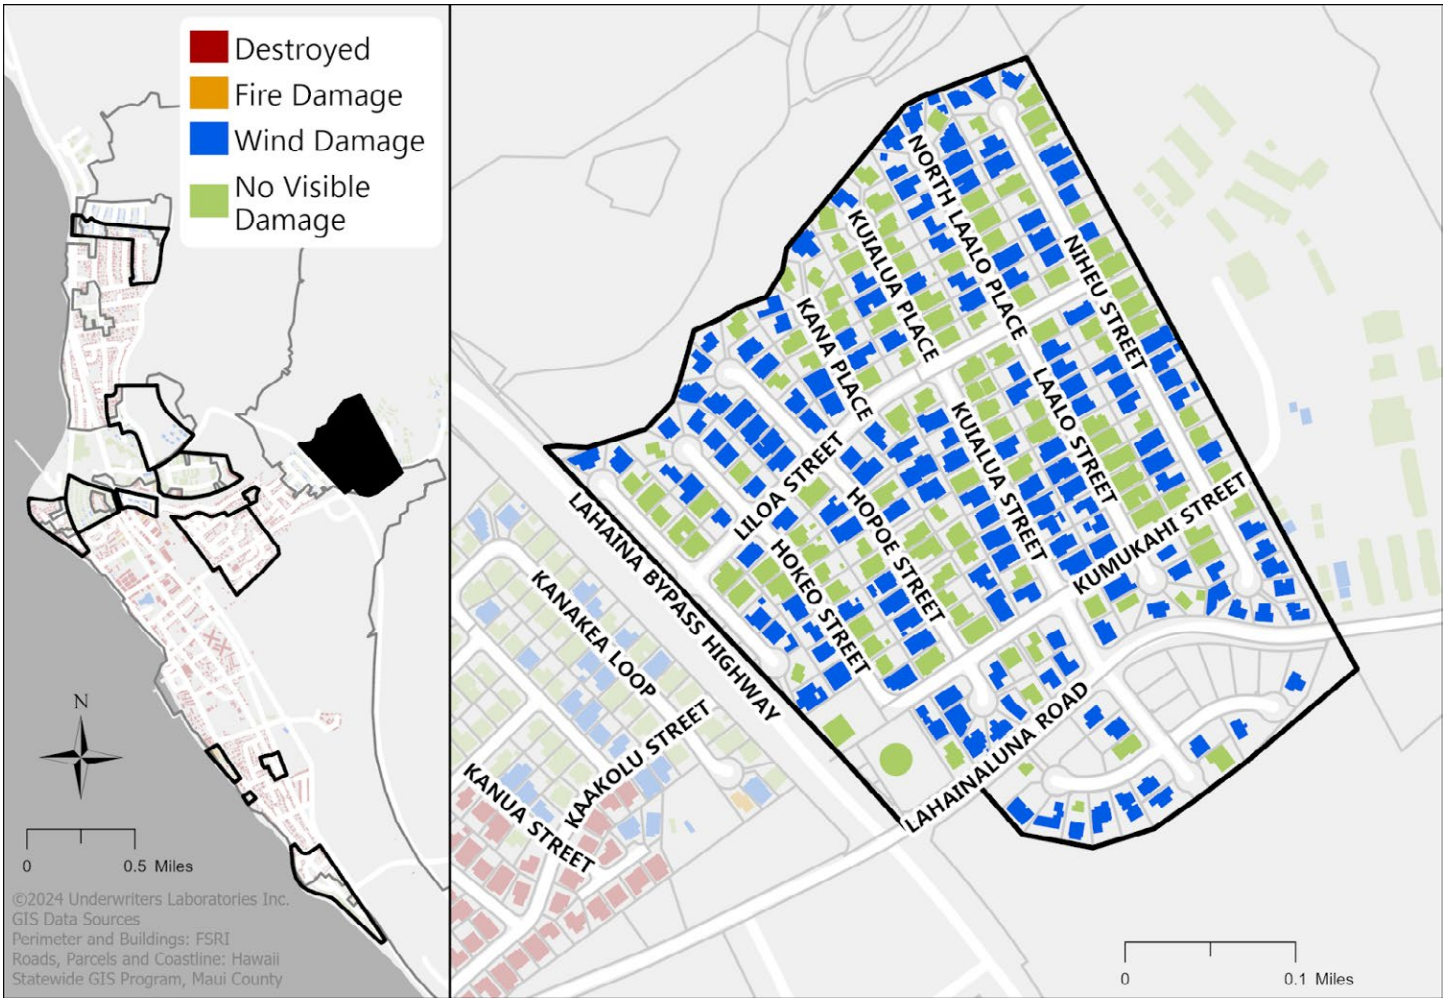
Figure 4.3.3.2.2 Damage classification assessment map of Kelawea Mauka III subdivision analysis area.

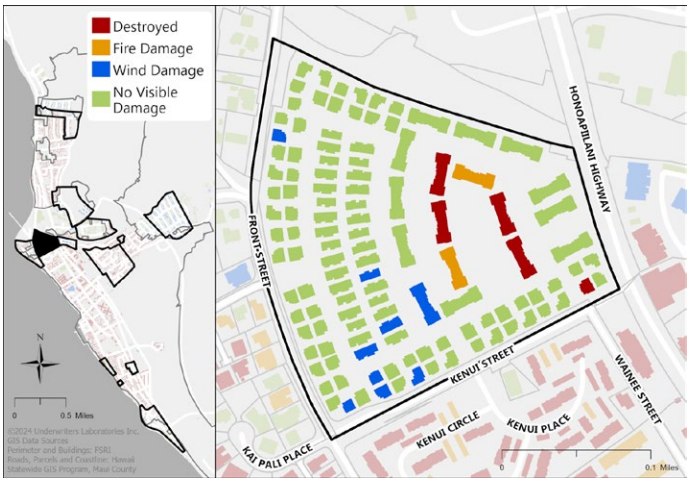
Figure 4.3.3.5.2 Damage classification assessment map of Kahoma Village analysis area.

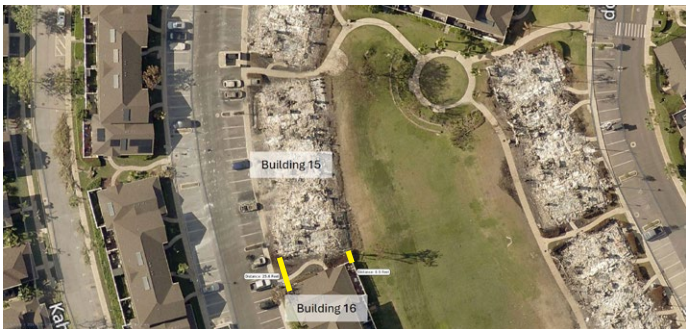
Figure 4.3.3.5.12 Distance between Building 15 (undestroyed) and Building 16 (destroyed) and several vehicles lost during the fire.

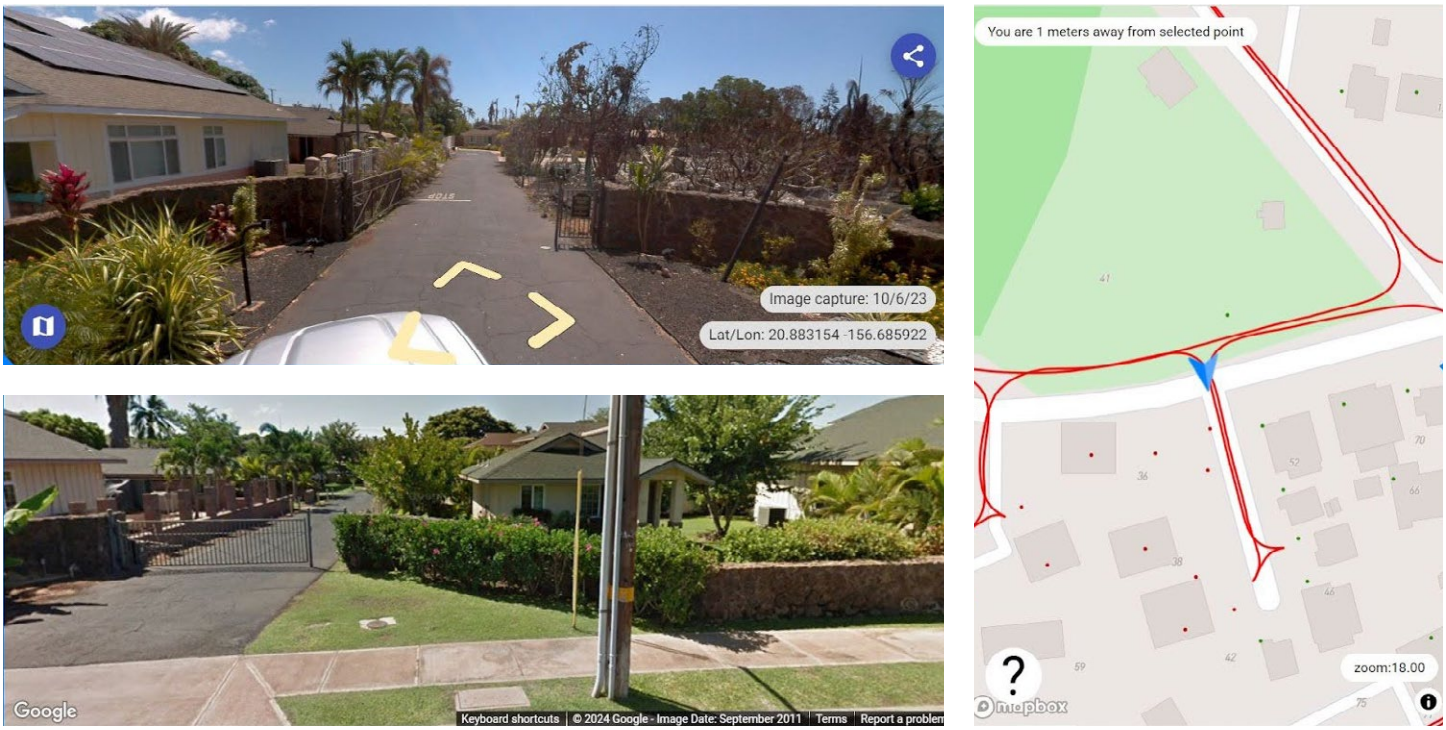
Figure 4.3.3.6.3 Pre- and post-fire Google Street View imagery of Ala Moana Street private driveway. This road is a demarcation of destruction, nearly all of the structures on the ocean (makai) side are destroyed.

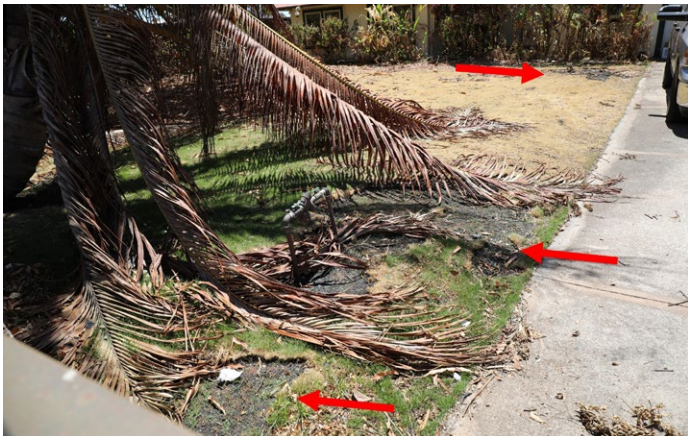
Figure 4.3.4.1.11 Ember-created spot fires in the front lawn of 4[redacted] Front Street (top). Bottom panel shows the map location and street image before and after the fire at 4[redacted] Front Street.

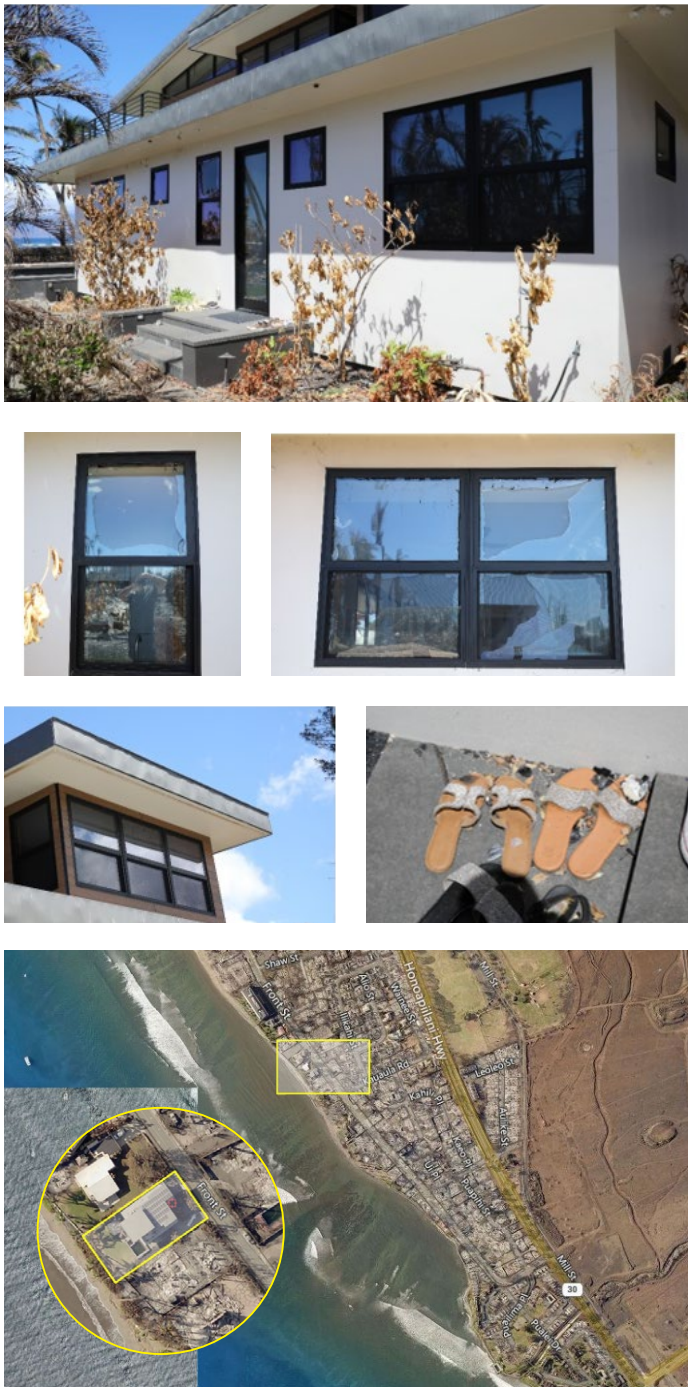
Figure 4.3.4.1.13 Window damage on the south side of 4[redacted] Front Street. Ember damage to shoes on doorstep indicates energetic embers were present in the area, which could have increased risk for ignition of interior combustibles had windows completely failed. Inset: Viewpoint showing the area depicted in the photographs above.

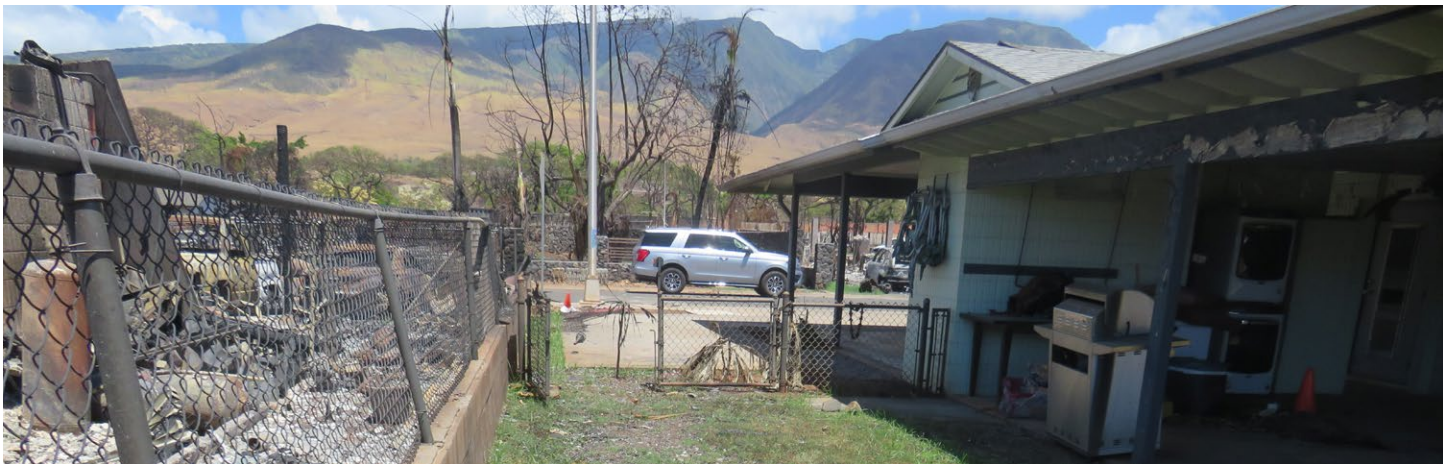
Figure 4.3.4.2.18 Radiant heat damage to the structure and household belongings at 4[redacted] ʻĀlīʻō Street was noted primarily on the north side.

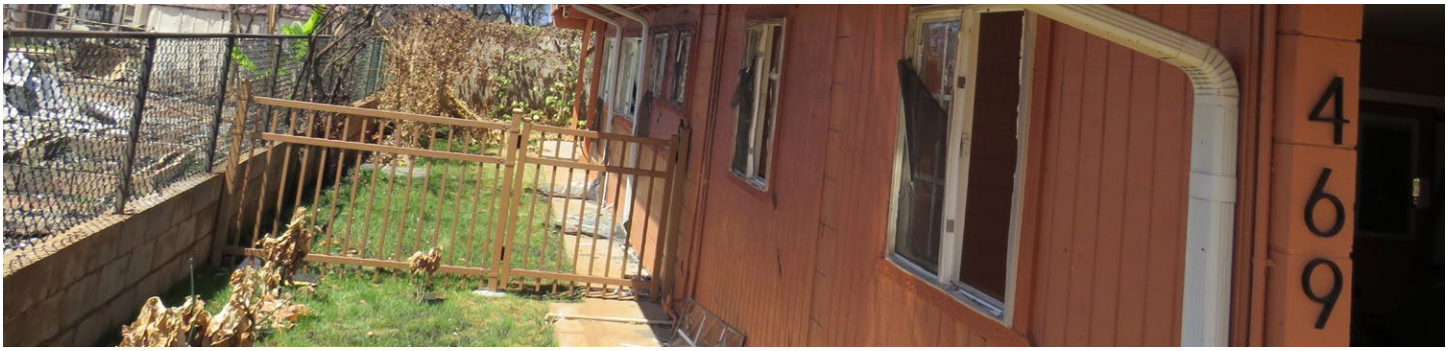
These large openings in the building envelope would have provided relatively easy access for embers to enter and accumulate inside this structure if enough energetic materials were transported to this area after the windows failed.

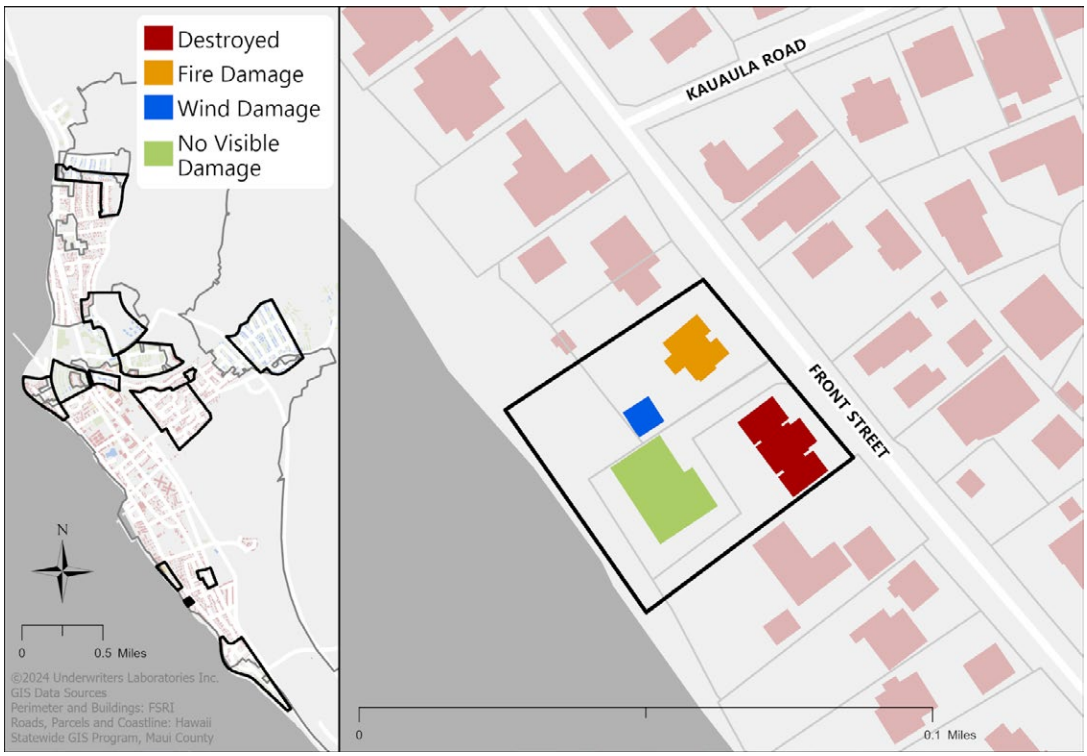
Figure 4.3.4.3.2 Damage classification assessment map of analysis area.

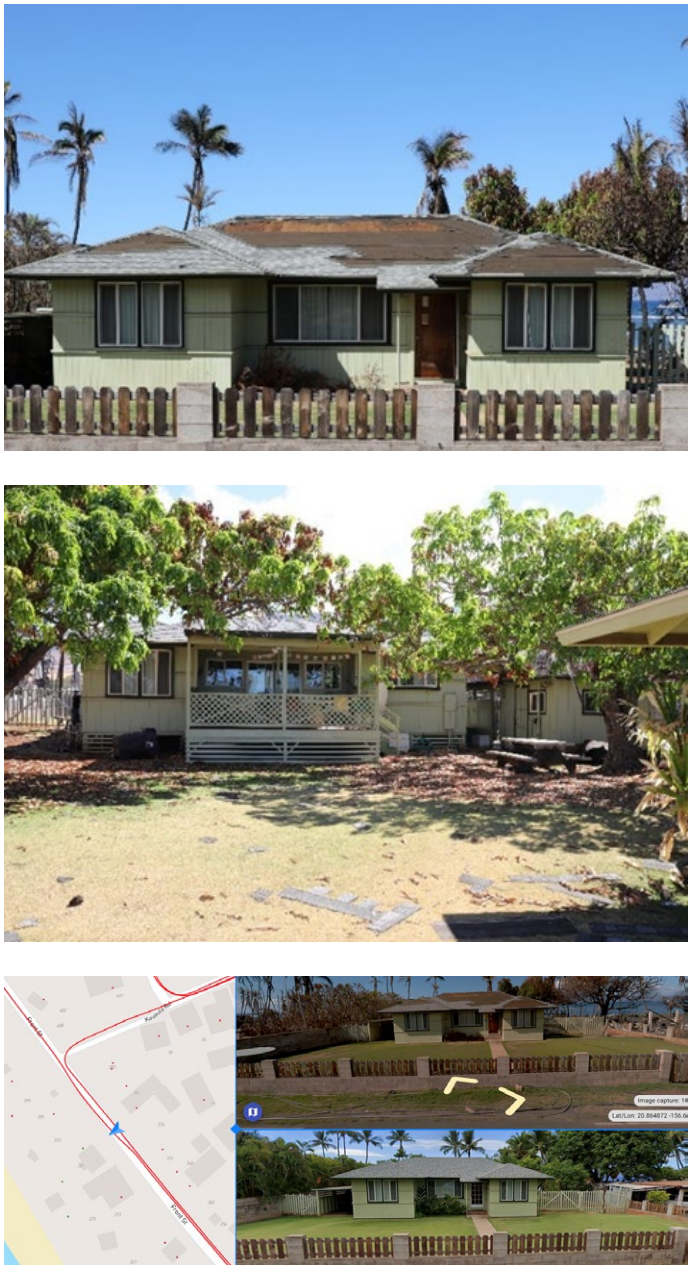
Figure 4.3.4.3.3 Strong winds removed shingles and tar paper from the roof of 3[redacted] Front Street (top) and deposited much of this material in the west (makai) rear yard (middle).

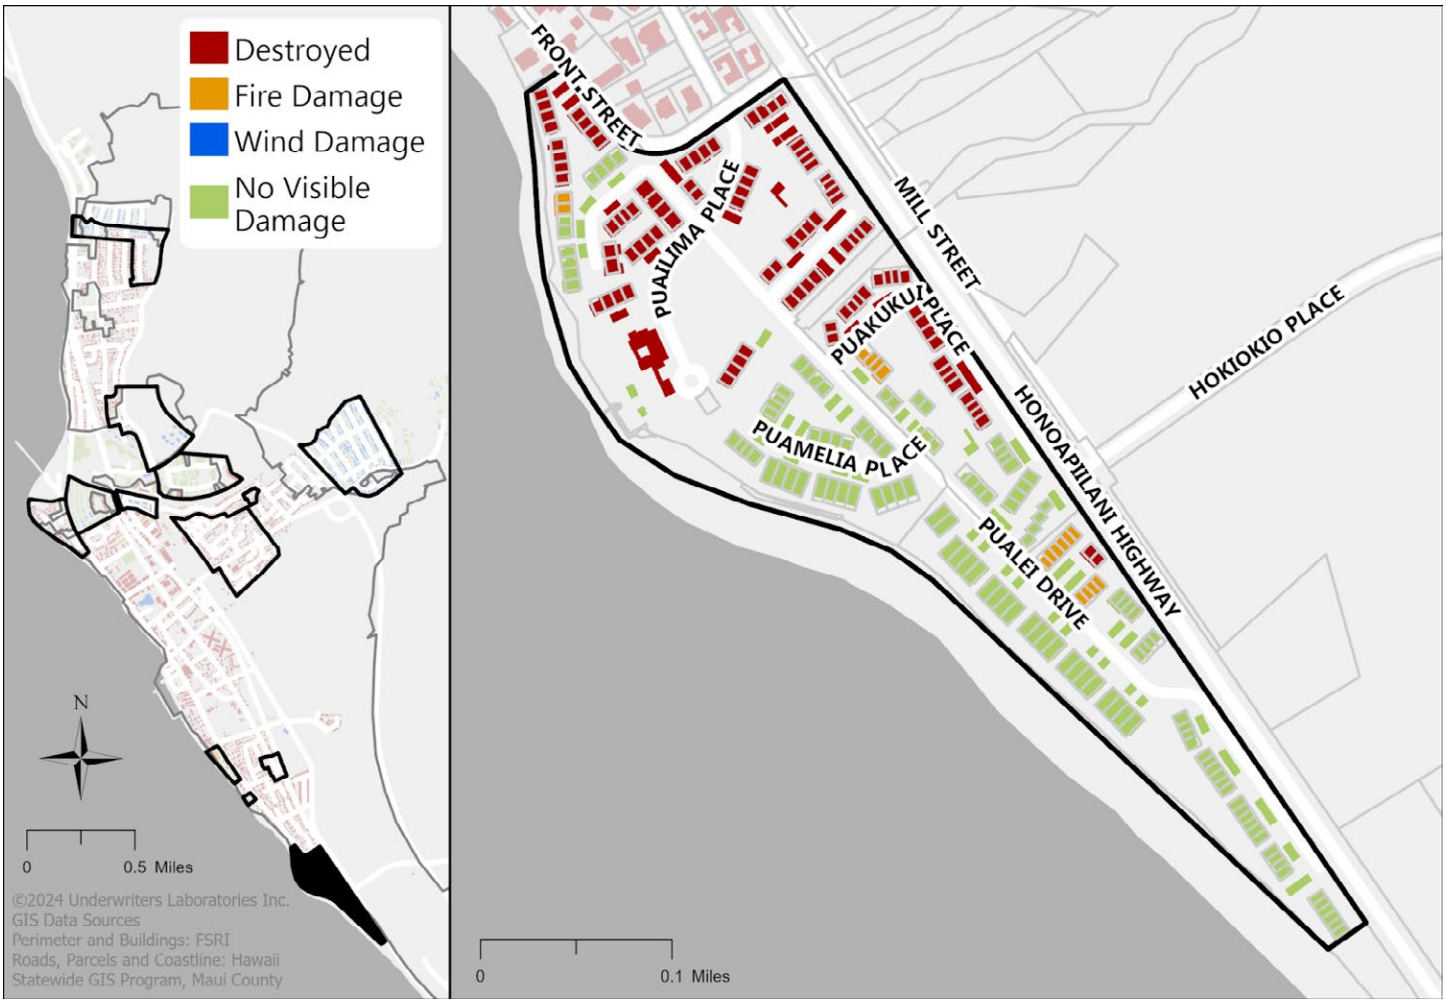
Figure 4.3.4.4.2 Damage classification assessment map of the Puamana Community analysis area.

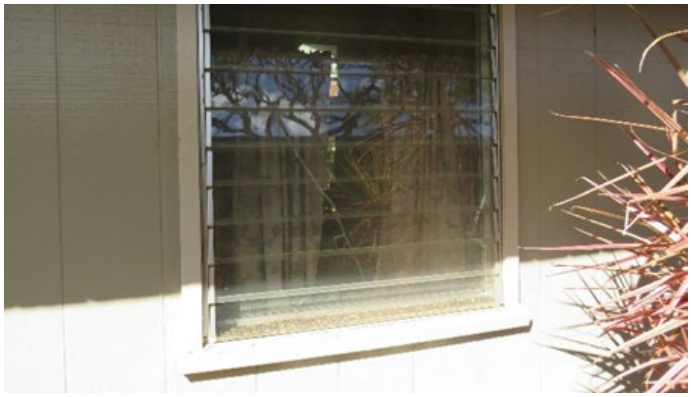
Figure 4.3.4.4.14 Louvered windows left partially ajar where debris collected, including charred remains of possible embers. An intact screen behind this window kept these materials from entering the structure and possibly igniting interior contents.

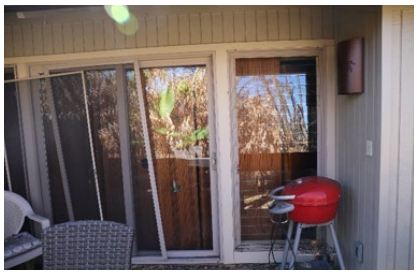
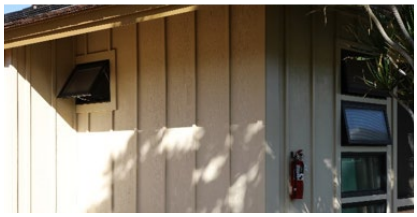
Figure 4.3.4.4.15 Examples of open/broken windows on surviving structures in Puamana.

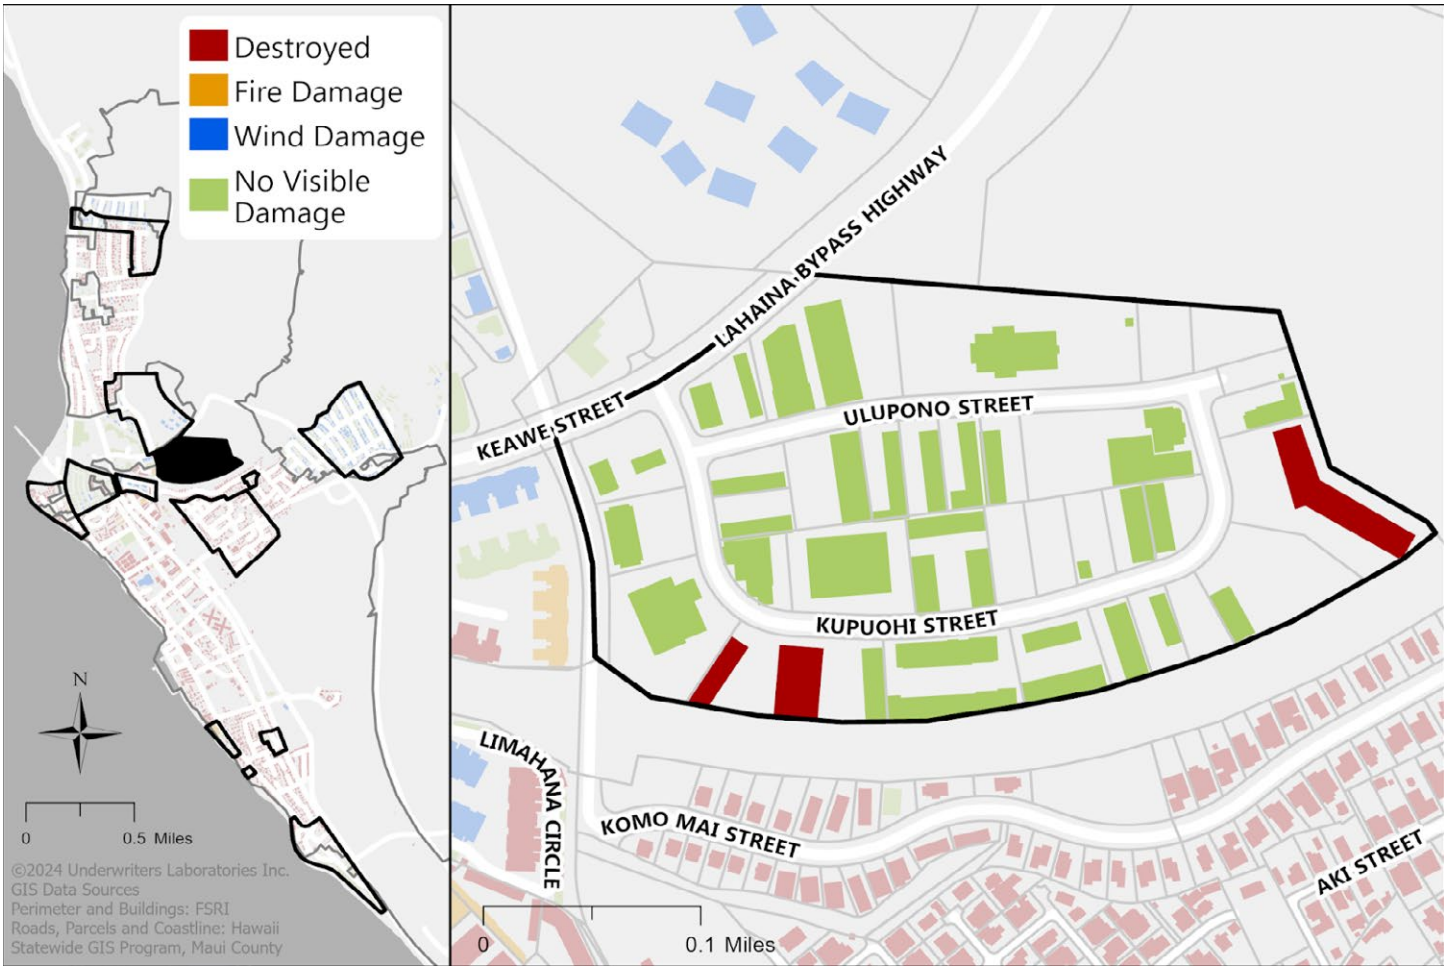
Figure 4.3.5.1.2 Damage classification assessment map of the Lahaina Business Park analysis area.

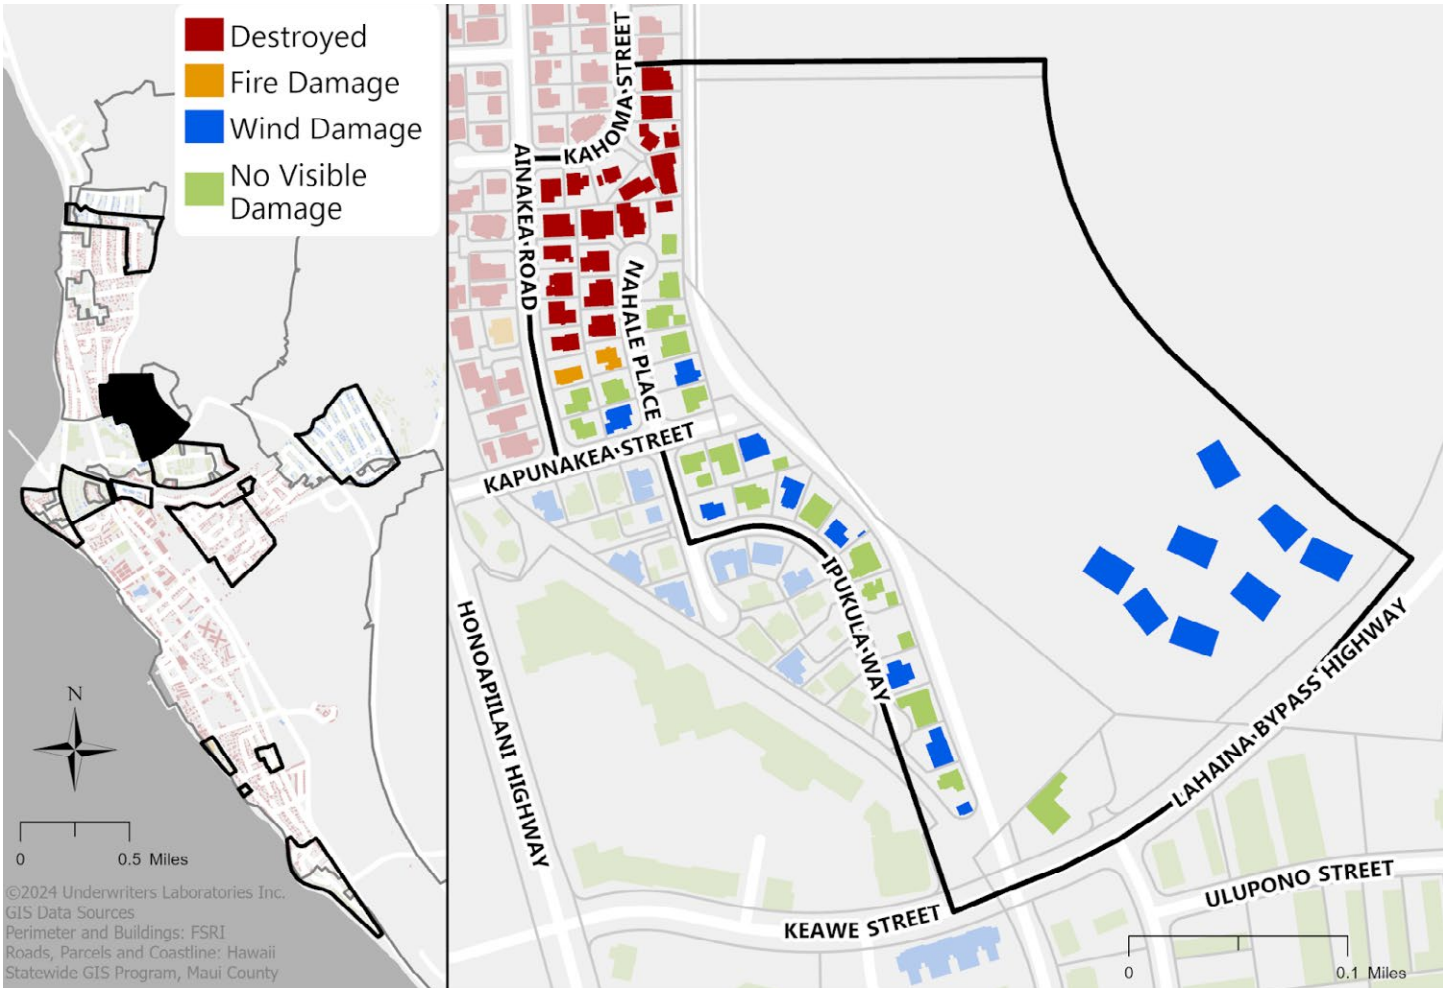
Just west (makai) of Oil Road are residential homes from Keawe Street, north to Kahoma Street (Figure 4.3.5.2.2). Undeveloped open fields consisting of unmanaged vegetation (buffelgrass and haole koa) are situated on the east (mauka) and north sides of the construction site.

Figure 4.3.5.2.2 Damage classification assessment map of the Keawe Street Apartments at the Villages of Leialiʻi analysis area.

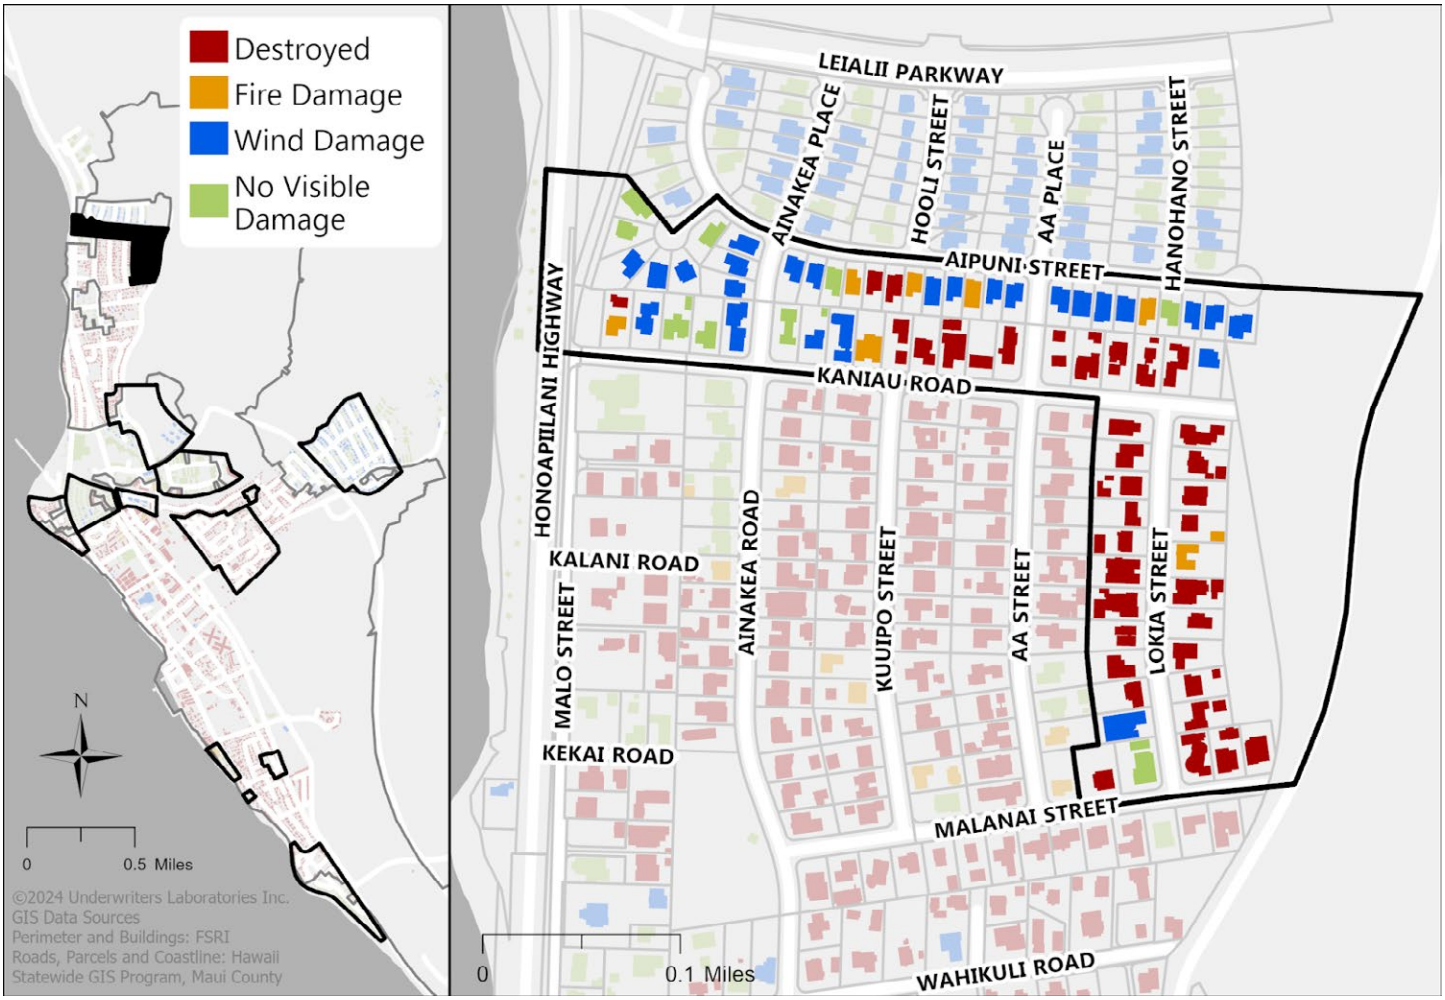
In the North zone, structures between Kaniau Road and ‘Aipuni Street were the northernmost structures to be destroyed by the fire (Figure 4.3.5.3.1). Only 13 of the 31 structures on the north side of Kaniau Road survived the fire, with most of the surviving structures grouped toward the west (makai) end of this road (Figure 4.3.5.3.2).

Figure 4.3.5.3.2 Damage classification assessment map of analysis area.

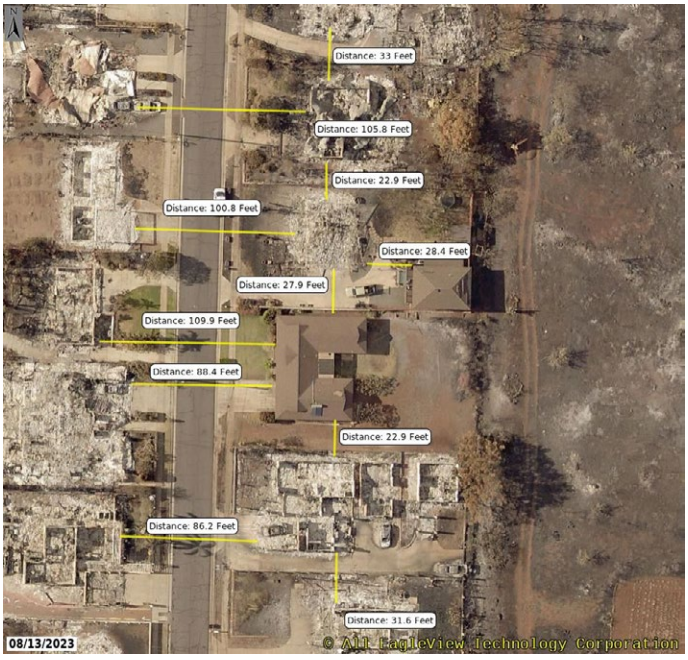
Figure 4.3.5.3.4 Structure spacing along Lokia Street in the vicinity of the surviving structures on the east side (mauka) of the street, abutting the grassland fire.

The vegetation fire in the grassland propagated into the east (mauka) yard of 16[redacted] Lokia Street, but had limited impact on the structure itself. A sprinkler was noted in the east (mauka) yard in the vicinity of where the vegetation fire ended.

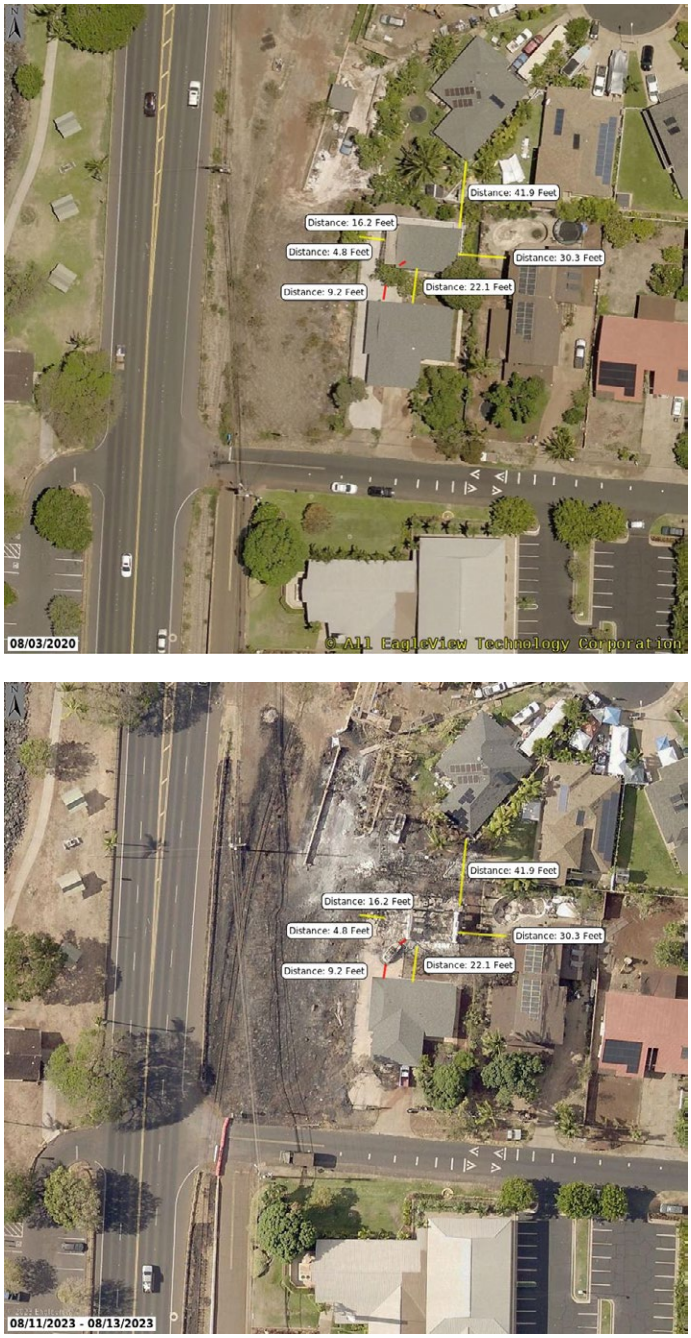
Figure 4.3.5.3.8 Structure spacing near destroyed accessory structure at 1[redacted] Kaniau Street.

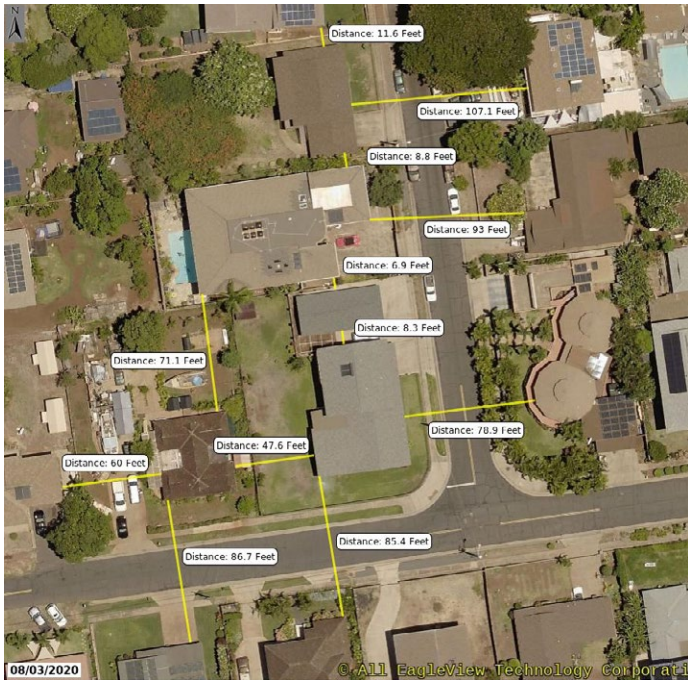
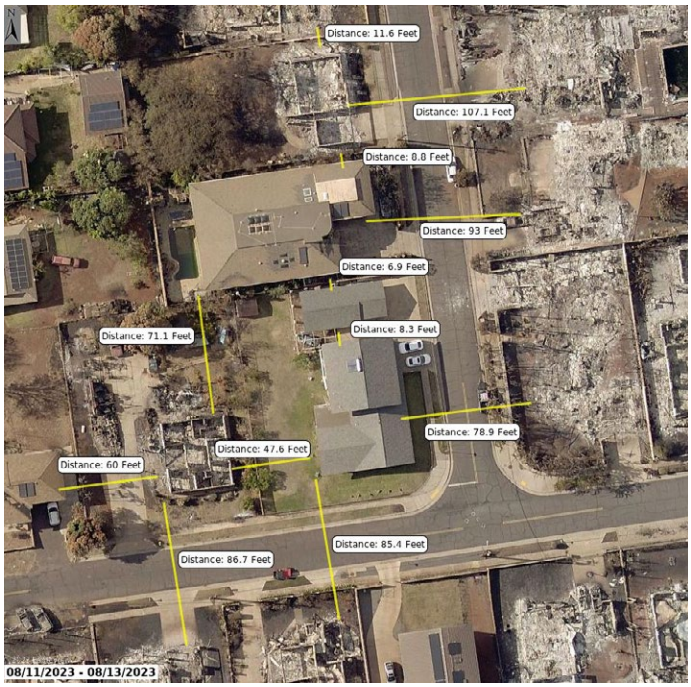
Figure 4.3.5.3.12 Structure spacing near surviving structures on the west side (makai) of the south end of Lokia Street.

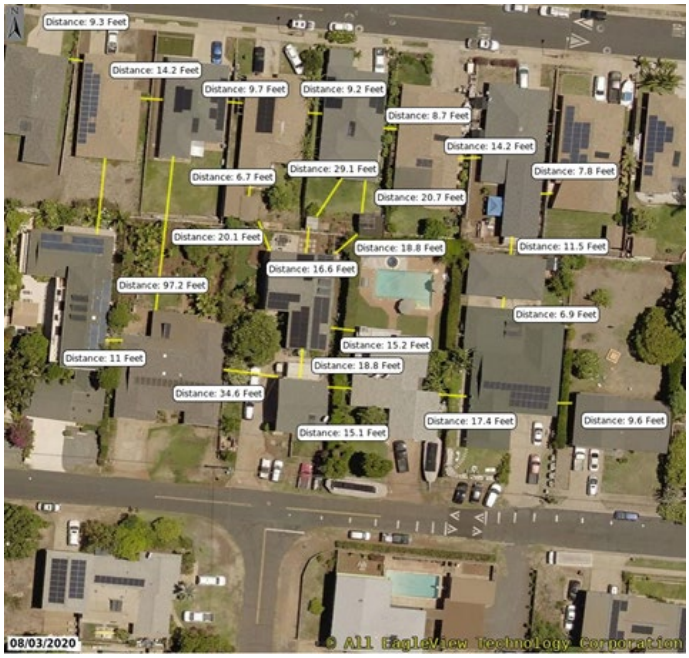
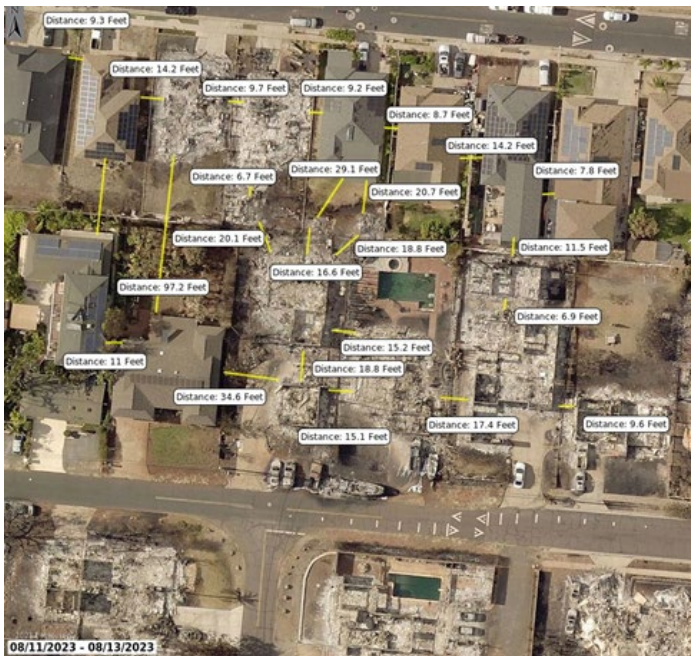
Figure 4.3.5.3.14 Structure spacing near surviving structures on the north side of Kaniau Street and south side of ‘Aipuni Street.

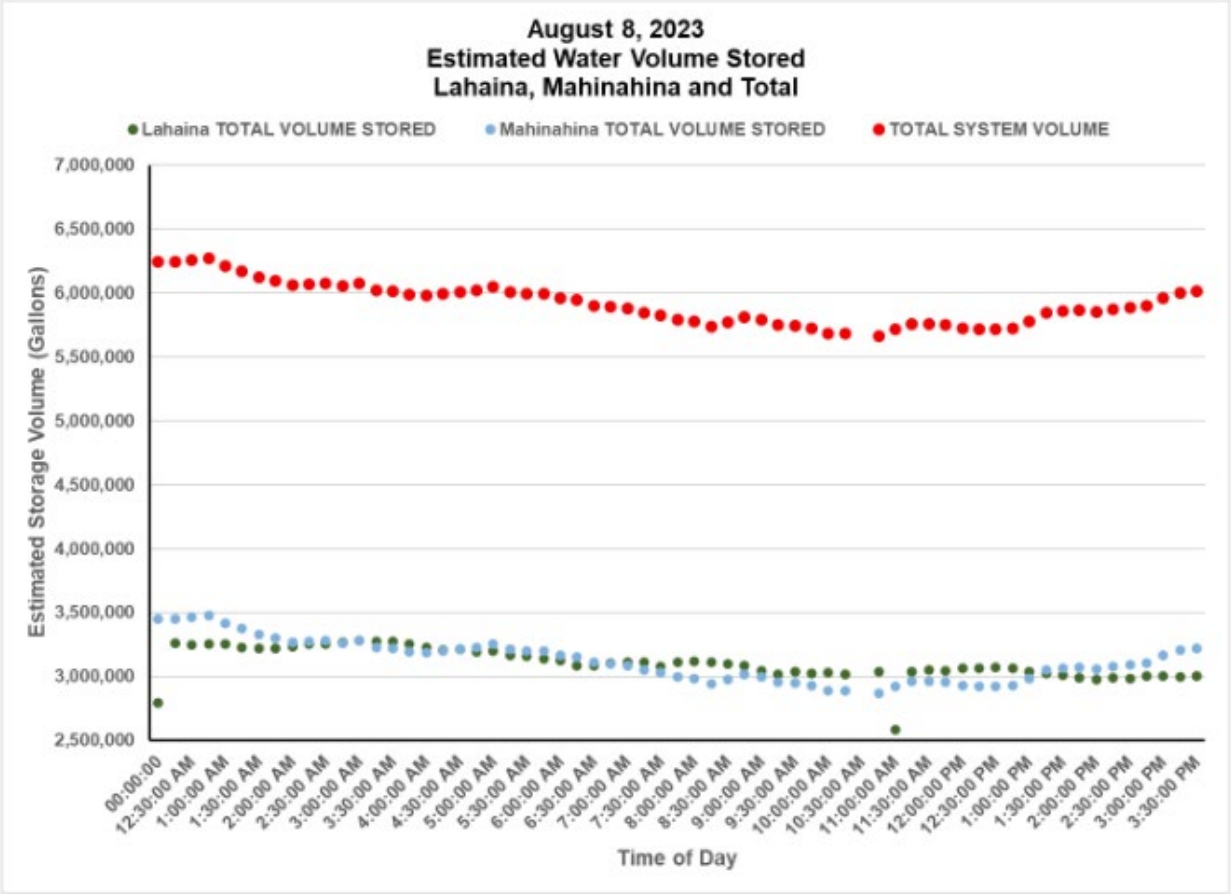
As per Figure 6.8.3, total system volume on August 8, 2023, ranged from just less than 7 MG to less than 6 MG until 15:30 when data was no longer available. Therefore, the amount of water stored in the two (2) systems met the state requirements for the required average daily demand until data was no longer available as described above.

Figure 6.8.3 Estimated water volume stored in Lahaina and Māhinahina on August 8, 2023.

Note: The volumes calculated in the graph above are preliminary estimates based upon the tank capacity and the tank level recorded by the system. The recording system stopped recording data at 15:30 on August 8, 2023.
